Product Service Bulletin

ISSUE DATE: March 30th 2019
Bulletin Number: FB 2019-01
SUBJECT: Reserve pin ripcord assemblies on Firebird EVO Harness Containers
STATUS: **MANDATORY BEFORE NEXT JUMP**
Affected HC: All Firebird EVO HC with Pillow Ripcord assemblies PN 012 built between April 2018-March 2019, Serial numbers BD 001-CB 010
To: All Firebird Dealers and Customers

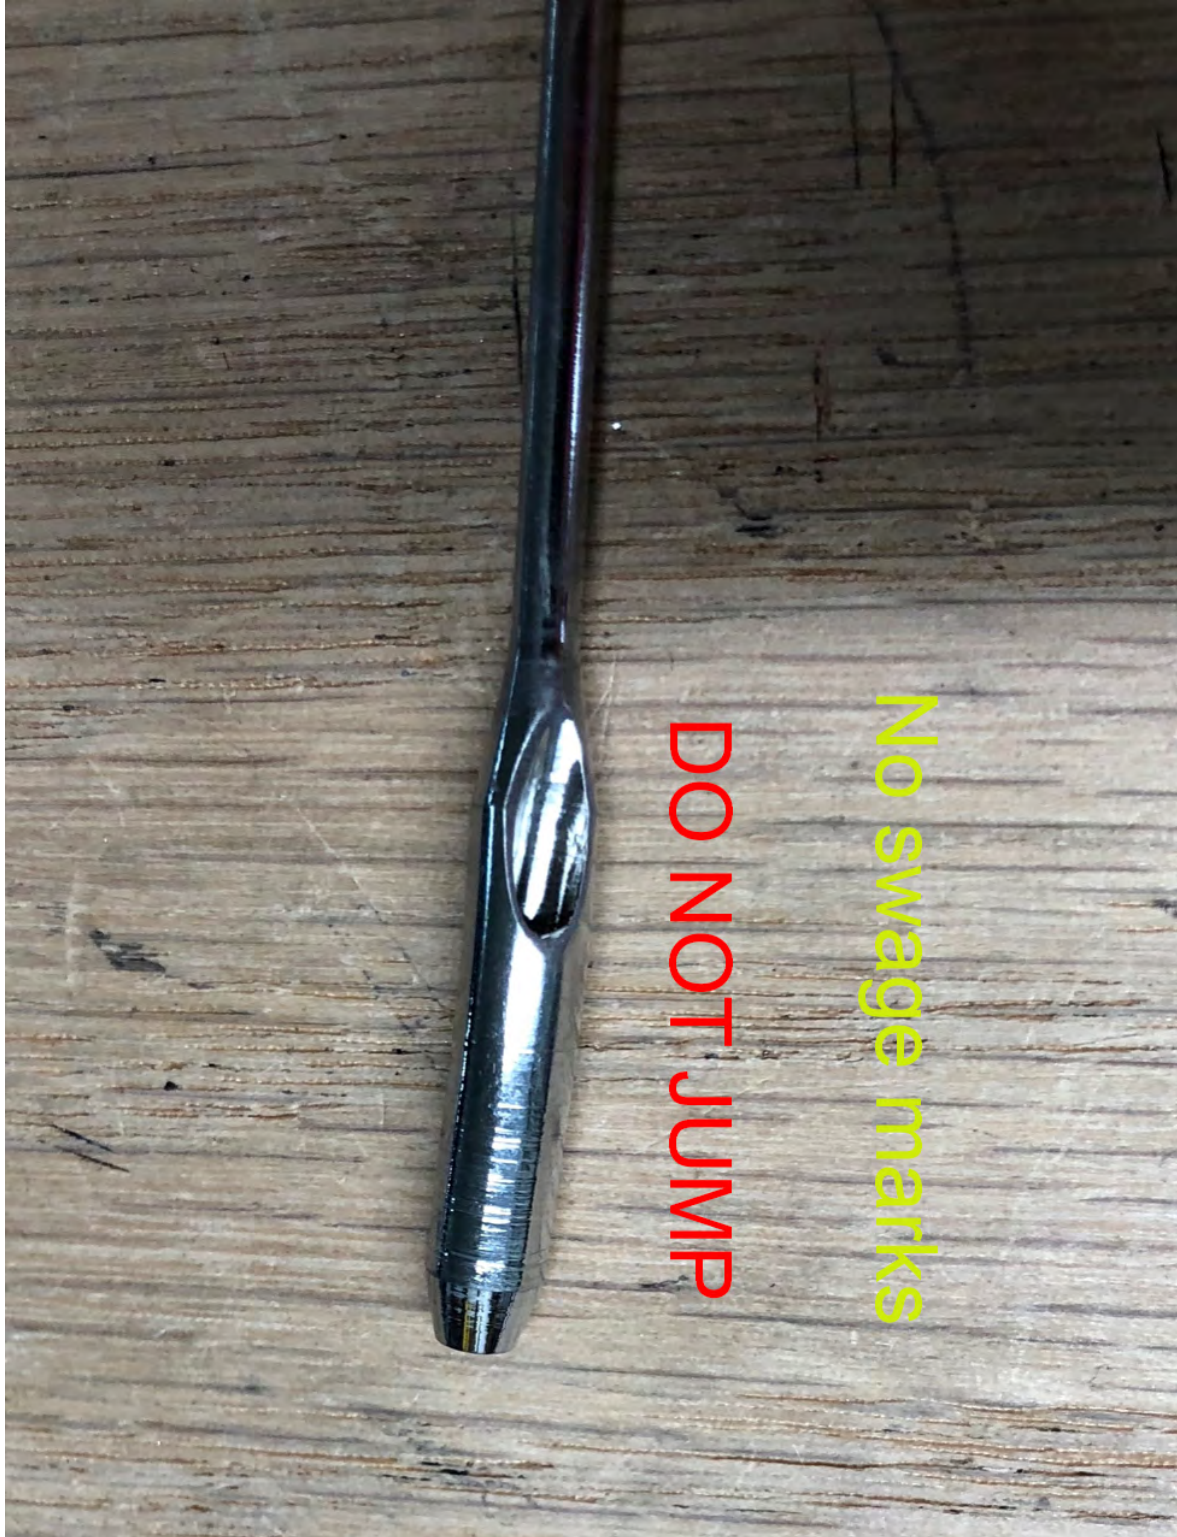
DO NOT JUMP

No swage marks

Contact Firebird per phone +1 7473008880 to arrange shipping of a new ripcord at no charge. You can send us pictures per email at usa@flyfirebird.com. Furthermore, the supplier agreed to pull test any ripcord that any customer wants tested.
