RIGGING ADVISORY CIRCULAR

RAC No. 321 Rev. A

SUBJECT:	PINTALL MAIN CANOPIES
<u>STATUS:</u>	MANDATORY
IDENTIFICATION:	The following canopies manufactured by PISA (Parachute Industries of Southern Africa):
	Pintail 144 (Part No. PO 817-00) Pintail 170 (Part No. PO 785-00) Pintail 120 (Part No. PO 866-00)
BACKGROUND:	During April 1991, customer reports of Pintail malfunctions became a source of major concern to PISA. On 17 April 1991, the company issued Service Bulletin 01/01/5004, in which Pintail canopies were temporarily grounded. The reason was to thoroughly re-evaluate the opening characteristics of the Pintail, in the light of these reports.
	The company concluded that, due to its unique shape, the Pintail was rather difficult to pack. Dealing with the tapered tail, as well as the slack in the D-lines, required a fair degree of care and attention, and that these were possible problem areas.
	With this in mind, a series of Pintails were modified, and have undergone as intensive evaluation programme.

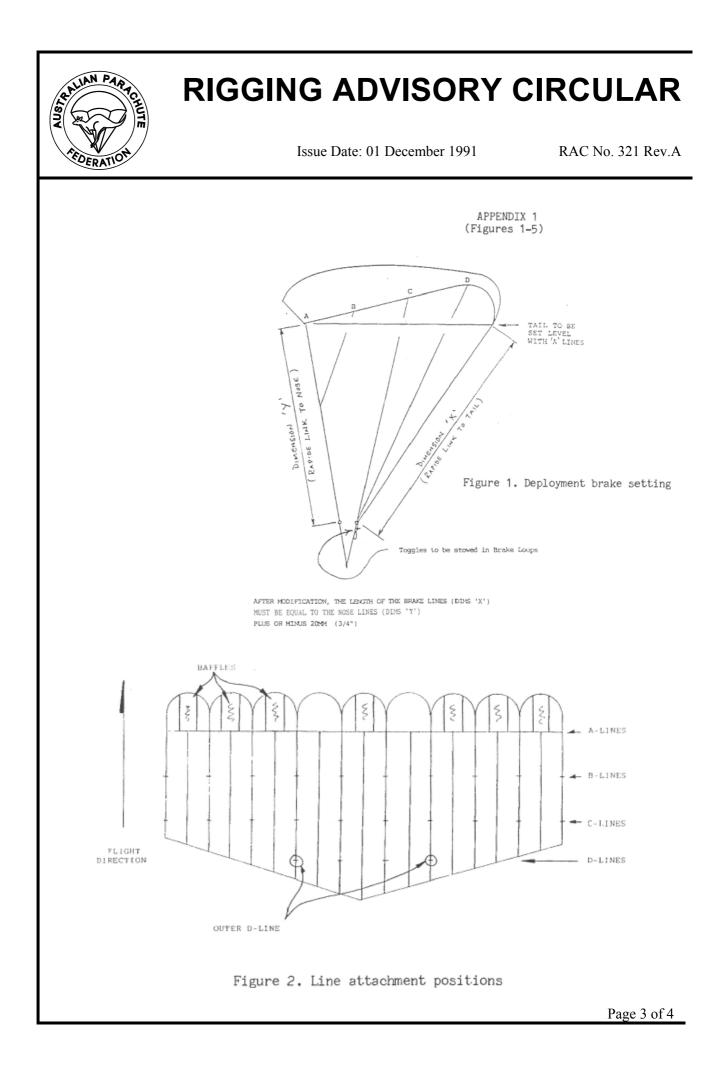
4. Cross-ports must be cut into the two ribs marked x-x-x-x on figure 3 of Appendix A. The size and position of the cross-ports are indicated in figures 4 and 5.

1. Reposition the deployment brake loops

a. The deployment brake loops on the two steering lines must be unpicked and removed;

b. These loops must be repositioned such that the length of the steering lines is <u>level</u> with "A" lines (plus or minus 20mm).

2. The D-line brake loops must be unpicked and removed.

3. The two <u>outboard D-lines</u> must be removed. This means that only two D-lines are left, one on each side of the centre cell. The line attachment tabs can be left in place.
