RIGGING ADVISORY CIRCULAR

RAC No. 329 Rev. A

SUBJECT: SWIFT PLUS RESERVES WITH SPECTRA-LINES

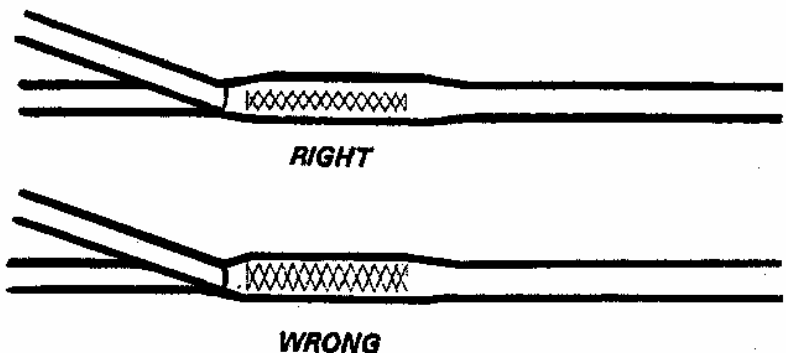
BACKGROUND: A Swift Plus reserve, serial No.R7-2218, manufactured 19 Feb 1992, was found to have a faulty bartack at the outer D line cascade. The width of the bartack was too wide to catch the finger trapped insertion of the cascade, allowing the cascade to be pulled free by hand.

MANUFACTURER ADVISORY: All bartacks of the suspension line sets must be subjected to a visual inspection and compared to the following drawing. "Good" bartacks will have a centered appearance and ample material on both sides of the stitches.

In the case of a defective bartack notify Para-Flite immediately providing the serial number of the affected parachute and a description of the location of the bartack and the nature of the defect. If you are not sure, please call before cutting the existing bartack.

The defective bartack may be replaced by any properly equipped and authorised repair facility and the bartack replacement costs can be invoiced or passed onto Para-Flite. Alternatively, the parachute may be sent to Para-Flite for repair, where it will be repaired free of charge.
