RIGGING ADVISORY CIRCULAR

RAC No. 427 Rev. A

SUBJECT: PARACHUTES DE FRANCE PRODUCT SERVICE BULLETINS

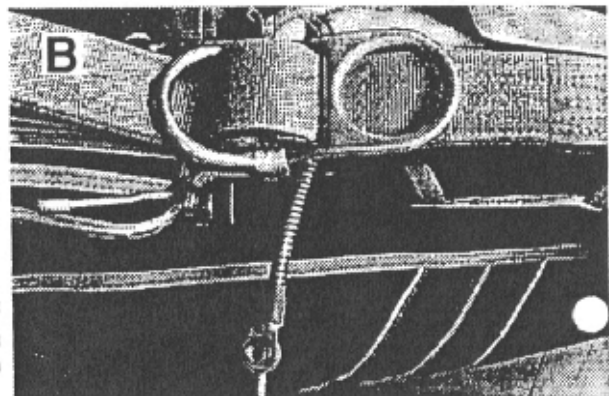
Note: picture C shows the former routing

- 2** Change the routing of the left release housing: it must go over the reserve ripcord housing (see picture B for right routing).

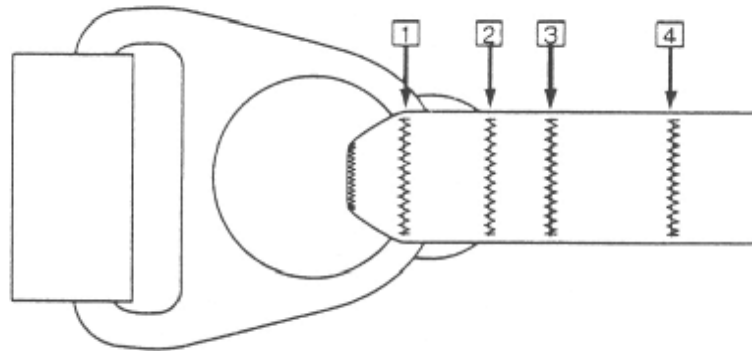
1) All versions manufactured before 20-10-92 (without identification stamp) carry 4 well-spaced bartacks, of which the lowest one is at the level of the harness ring. In addition, there is a bartack folding the webbing at the end of the riser, where the middle ring is attached.

ATTENTION: These risers may not function properly! It is mandatory to verify airworthiness with the help of a suspended harness. In case of high release force, or no release, return the risers to our factory for a modification free of charge.

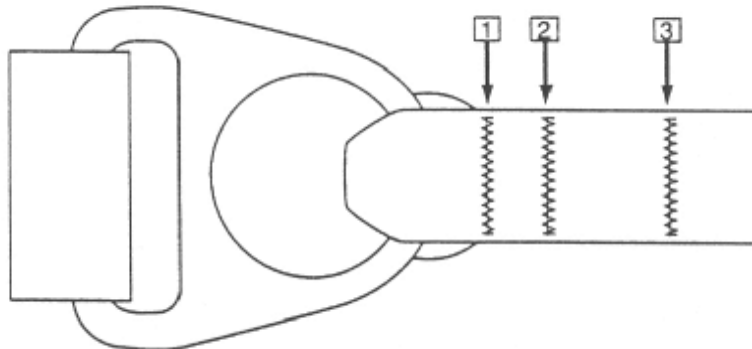
2) Mini-risers built between 20-10-92 and 25-04-93 are marked with a stamp "0" (zero) between the two legs. They carry only three bartacks, of which the first one is positioned a lot higher than before.

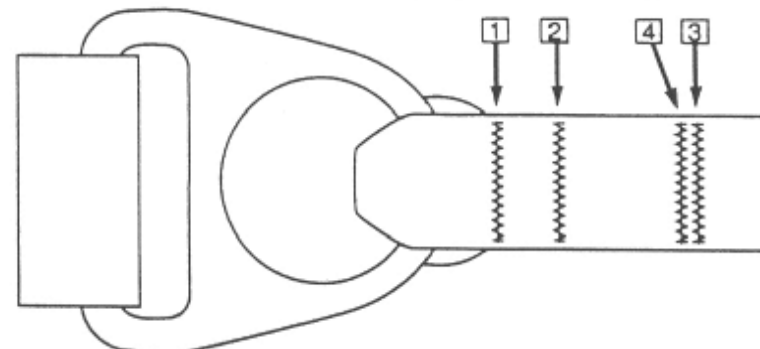
3) Effective 24-04-93 we have added a fourth bartack just below the top one, to reinforce the attachment of the small lip. Note that this bartack is placed on the inside, so as not to affect the mechanical dimensions. This latest generation of mini-risers are marked with stamp "1" (one) between the two legs.
