RIGGING ADVISORY CIRCULAR

RAC No. 803 Rev. A

SUBJECT: ADVANCED AIR SPORTS 3-RING RISER INSPECTION

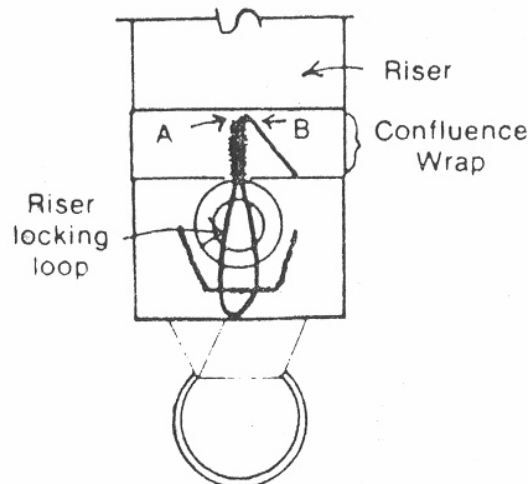
BACKGROUND: A recent incident occurred where a jumper participating in canopy RW had a riser release unintentionally at approximately 1200ft above ground level. The jumper was able to successfully break away and deploy his reserve. On landing the riser was examined and it was found that one side of the release locking loop pulled out of the riser confluence wrap and bar-track sewing. Further investigation has determined that all risers manufactured by Advance Air Sports Products (AASP) between February and December 1979 (including container assemblies 792-1048) were made similarly, according to the current instructions from the Relative Workshop. These call for the excess loop material to be cut off (as shown in example A). This does not leave any margin for error in placement of the bar-tack holding the two running ends of the loop to the webbing. If this bar tack is not perfectly centred on the two ends and abnormal opening shock can put enough pressure on the loop to pull one of the ends out of the stitch pattern.

All other risers made by AASP have the excess loop material turned up and sewn under the confluence wrap (as shown in example B), preventing either side from pulling free. During a static pull test with a 100lb load on the riser assembly, there was a 25lb load on the loop.

This notice is requiring all owners of AASP risers purchased between February and December of 1979 and Container assemblies 792-1048 to check each riser release locking loop by putting it over a nail or other round object and applying 50lb pull. Any AASP risers that do not withstand this test are to be returned to the manufacturer for replacement.
