RIGGING ADVISORY CIRCULAR

RAC No. 817 Rev. A

SUBJECT:	MS 22040-1 INSPECTION
STATUS:	MANDATORY
IDENTIFICATION:	Adjuster part no. MS 22040-1 manufactured by United States Forgecraft identified with a date of manufacture Fc 92.
<u>BACKGROUND:</u>	The Relative Workshop product service bulletin 062193 dated 21 June 93 has identified incorrectly manufactured MS-22040-1 adjusters on Vector container systems manufactured between 22 April 93 and 10 June 93. NOTE: This problem may not be restricted to Relative Workshop Vector systems. Over the last 10 years there have been a number of reported instances of leg strap webbing slippage on other brands of equipment. Adjustable 'V' ring MS70113, MS70102 and MS27765 may also be succeptable.
<u>RELATIVE WORKSHOP</u> <u>POLICY:</u>	At the next scheduled reserve repack, inspect Vector systems with serial numbers between 21732 and 28674 which have MS 22040 adjusters fitted, against the following diagrams. If hardware is correct, note bulletin compliance on data card, if hardware is incorrect, notify Relative Workshop. Check for this hardware on: leg straps (tandem & sport harness) and, chest straps (tandem and tandem passenger harness).

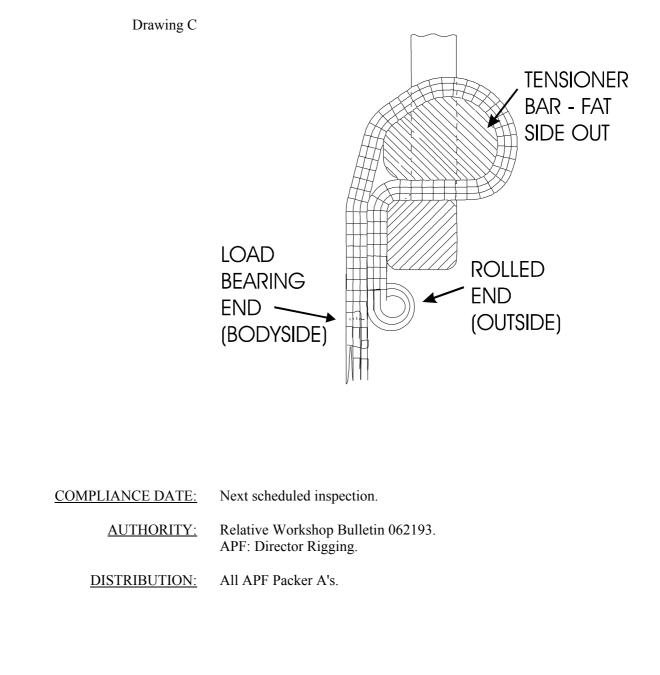
To aid in the identification of incorrectly assembled hardware refer to Drawing C following.

<u>APF POLICY:</u> At the next scheduled reserve inspection, check <u>ALL</u> parachute systems which incorporate MS22040-1 adjusters and other hardware using the same sliding tensioner bar in their construction. If hardware is incorrect, notify the manufacturer of the defect and have a Rigger or the manufacturer rectify the equipment.
