AVA AD 2012-06-20

AVALON Harness Containers

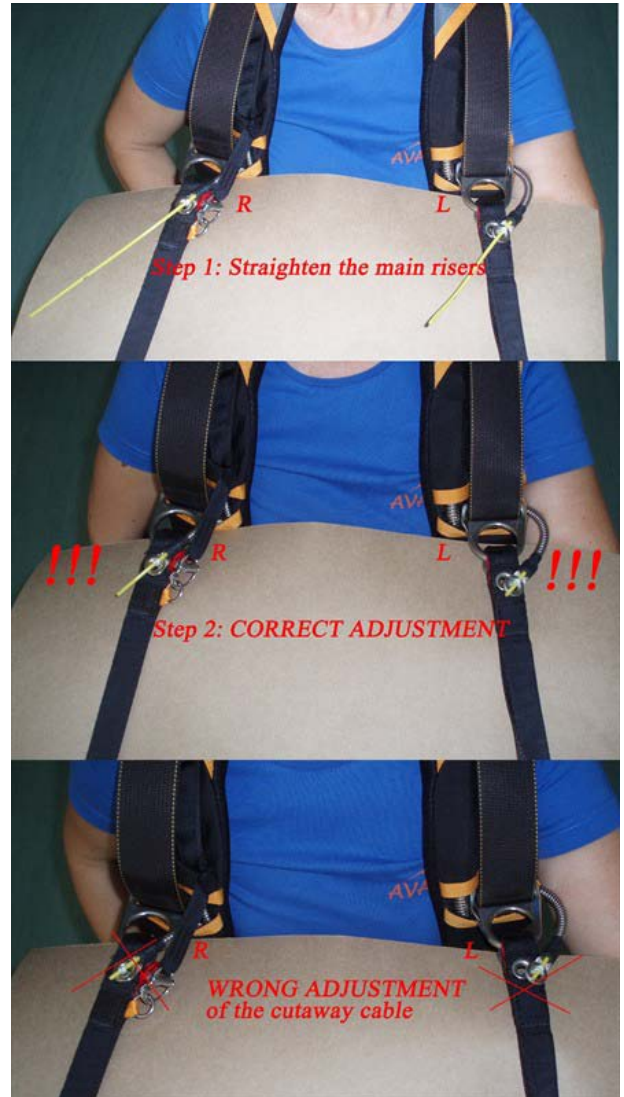
On 17.06.2012 in Moldova after a malfunction of the main canopy the pilot makes a cutaway. The video shows that the right main riser with the RSL split seconds earlier than the left one. This is unusual and abnormal situation. The RSL is equipped with an extra belt and in this case it helped the left riser to cut away and normal reserve opening to be achieved.

We are issuing this AD to detect and correct any incorrectly assembly of the cutaway cables length. This condition if left uncorrected, could lead to wrong rescue opening and twisting of both (main and reserve) canopies.

1. Put the harness and straighten the main risers.
2. Check the length of the cutaway cables (see the pictures for correct adjustment). The left main riser must be released prior/before the right one with the RSL. That's mean the right cutaway cable (with the RSL) should be longer than the left one.
3. The left main riser must be released 15 mm ($\frac{1}{2}$ inch) prior/before the right one with the RSL.
