**TECHNICAL & SAFETY COMMITTEE**  
**INTERNATIONAL PARACHUTING COMMISSION (FAI)**

<p><b>Technical &amp; Safety Information Notice No.</b></p>	<p><b>02/2009</b> <span style="float: right;"><b>W.N. 23</b></span></p>
<p><b>Date of Issue</b></p>	<p><b>09 February 2009</b></p>
<p><b>Subject Matter and Applicability</b></p>	<p><b>Sun Path Products Inc.</b>  <b>SERVICE BULLETIN #SPSB005, dated February 3 2009</b>  <b>Re JH1013 (HIP RING MLW) AND JH1014 (4 RING MLW) RING DAMAGE</b></p> <p><b>SUBJECT: HIP RING AND 4 RING MAIN LIFT WEB INSPECTIONS</b></p> <p><b>IDENTIFICATION:</b>          ALL SPORT JAVELIN ODYSSEY HARNESS/CONTAINERS WITH <i>HIP RING OR 4 RING</i> MAIN LIFT WEB, WITH DATE OF MANUFACTURE BETWEEN <b><u>SEPTEMBER 2008 AND DECEMBER 2008.</u></b></p> <p><b>BACKGROUND:</b>          It has been brought to our attention that the hip ring on JH101-3 (Hip Ring Only) and JH101-4, (4-Ring) main lift webs, may have been struck by the needle used for installing the 5 cord harness stitching. This needle strike on the hip ring may cause damage to the Type 12 buffer, 5 cord stitching and possibly the Type 7 webbing. As a precaution, <b><u>a mandatory inspection of the hip rings is required

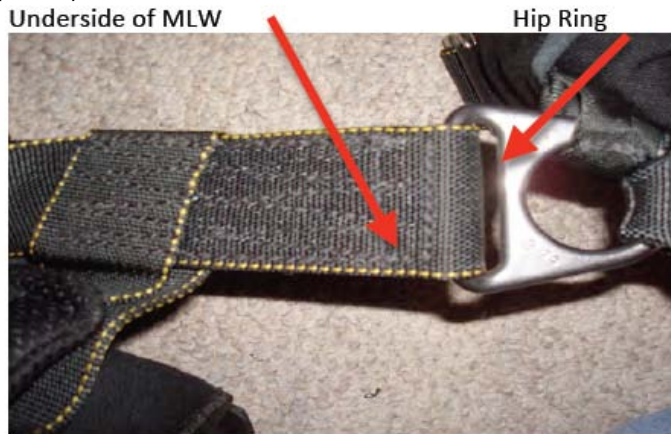
Turn Main lift web over, to expose the underside of the MAIN LIFT WEB (MLW).

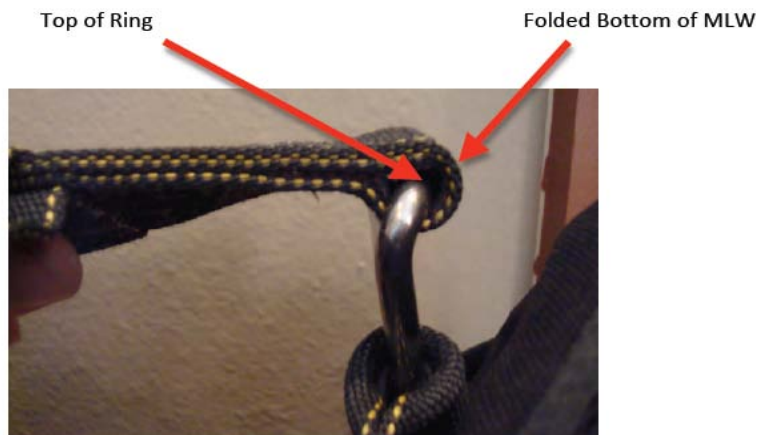
5. Rotate Hip ring and leg pad 90 degrees downward as to expose the top of the ring to the inside of the folded bottom end of the MLW webbing, as shown below.

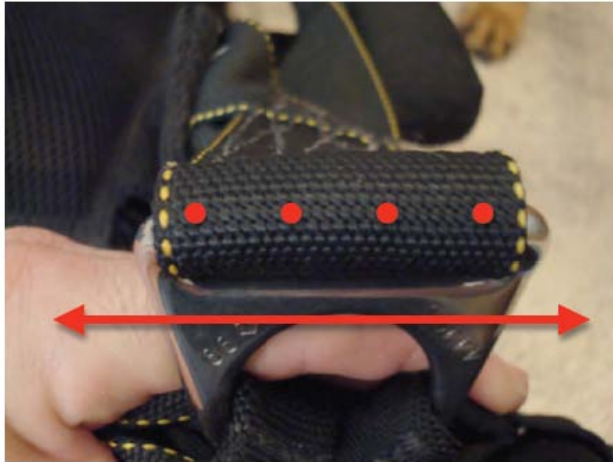
6. Move the hip ring back and forth (side to side) and rotate inside the webbing, while pressing the top of the ring through the webbing. If a needle strike is present, the rough spot on the top of the webbing bar of the ring will catch or snag on the TYPE 12 buffer on the inside of the TYPE 7 MLW. This will feel like a rough spot(s) on the top of the bar and cause a rough or snagging feel.

**FEEL HERE FOR DAMAGED RING INSIDE WEBBING. DAMAGE WILL MOST LIKELY BE ALIGNED WITH THE BOTTOM POINTS OF THE 4 POINT STITCH PATTERN.**

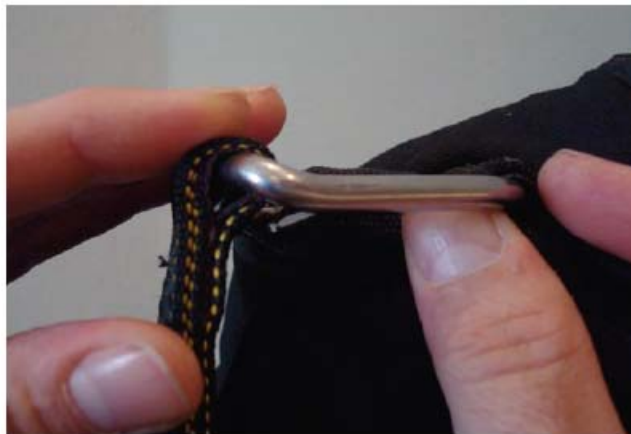
**BACK AND FORTH/ SIDE TO SIDE MOTION**

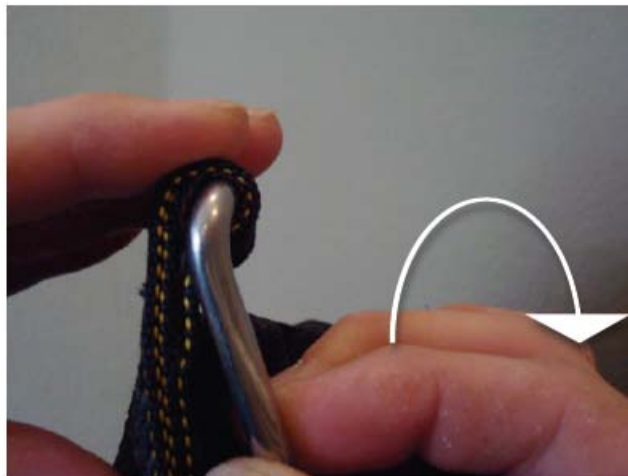
**ROTATE DOWWARD**
