TECHNICAL & SAFETY COMMITTEE
INTERNATIONAL PARACHUTING COMMISSION (FAI)

<p><i>Technical & Safety Information Notice No.</i></p>	<p>03/2010 W.N. 30</p>
<p><i>Date of Issue</i></p>	<p>09 August 2010</p>
<p><i>Subject Matter and Applicability</i></p>	<p>Note – The parachute systems in question are NOT sport parachuting rigs, but pilots’ rigs. This Information Notice is being disseminated to inform Riggers who may be asked to repack one of these systems, and as a general guide to Riggers to be aware of this issue if it should appear at a future stage with a sport parachute system.</p> <p>PARACHUTES AUSTRALIA 22 Bosci Rd, Ingleburn NSW 2565 Australia (PO Box 969) Ph: + 61 2 98295355 Fax: +61 2 98291300 Email: sales@parachutesaustralia.com</p> <p>SERVICE BULLETIN No PA SB1001 Issued 9th August 2010</p> <p>SUBJECT: THINBACK AND SLIMPACK 2 RIPCORD HOUSING CLAMP</p> <p>STATUS: MANDATORY</p> <p>IDENTIFICATION: Thinback Harness & Container System Part No. S005-() manufactured between July 2009 and June 2010 serial numbers: 5036, 5037, 5038, 5039, 5040, 5041, 5042, 5043, 5044, 5056, 5057, 5058, 5059, 5060, 5087, 5088, 5089 and 5096 Slimpack 2 Harness & Container System Part No. S003 manufactu

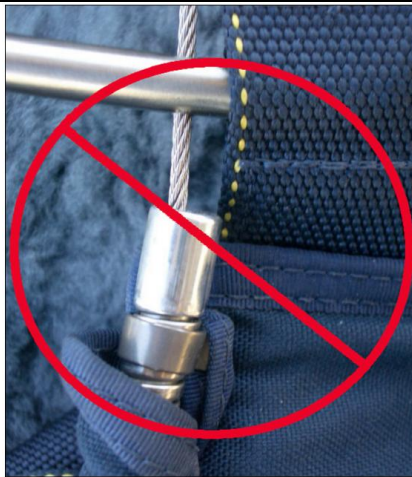
Image 1

Thinback and Slimpack 2 harness and container systems contained within the above mentioned serial numbers that has a housing clamp installed “below” the housing end cap are to be removed from service and returned to the manufacturer for rectification.

Effected equipment to be returned to Parachutes Australia are to be sent by Registered Post to the above address. The registered post cost will be refunded to the sender upon return of the equipment.

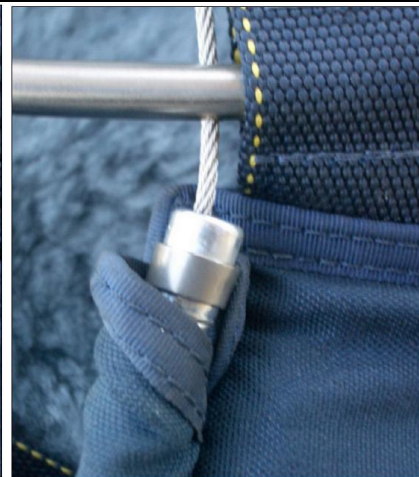
Image 2

Thinback and Slimpack 2 harness and container systems contained within the above mentioned serial numbers that has a housing clamp installed on the housing end cap are unaffected and can remain in service.
