# TECHNICAL & SAFETY COMMITTEE

<b>Technical &amp; Safety Information Notice No.</b>	05/2011 Virgil AAD W.N. 40
<b>Date of Issue</b>	06 October 2011
<b>Subject Matter and Applicability</b>	<b>VIGIL AAD CUTTERS EMERGENCY PRODUCT SERVICE BULLETIN # PSB-7</b> <b>SUBJECT:</b> Inspection of Vigil AAD Cutters produced in October 2007. Part No. - 9582006 Date of Manufacture – 10-07 (mm-yy)
<b>Background Information</b>	<p><b>BACKGROUND:</b> The following incident occurred on the 14<sup>th</sup> September 2011 at the Saint-Jean Chrysostome (Canada) drop zone. A skydiver failed to deploy his main canopy and manually pulled his reserve handle with insufficient altitude to fully deploy the reserve canopy. During the investigation of the incident it was discovered that the loop was neither cut nor trapped by the cutter.</p> <p>In the preliminary report prepared by the Royal Military Academy, it was stated that the knife blade was missing. (See the separate Royal Military Academy report.) Vigil R&amp;D has confirmed that the electronics worked correctly and fired the cutter, but because of the absence of the knife blade, the closing loop could not be cut. <b>This cutter was part of a production

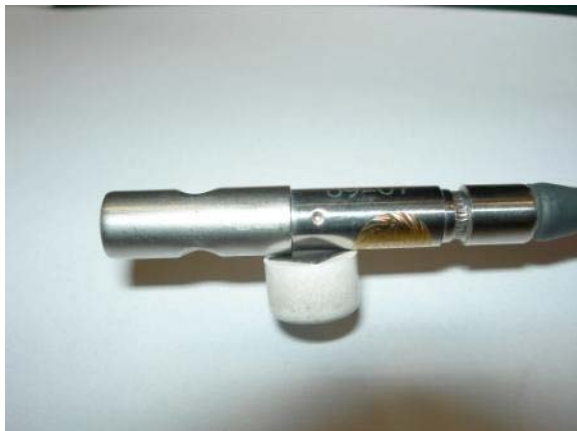
2A

In the interest of additional safety, we have devised a field test, which can be performed on any Vigil cutter, using a magnet to confirm the presence or lack of a knife blade. It can be done using any magnet on any cutter. Either a small (see Photo 2A) or a larger (see Photo 2B) magnet may be used. If there is a knife blade present, the magnet will be attracted to the knife blade.

For additional safety, we highly recommend that the magnet test be performed on each cutter manufactured prior to June 2008.

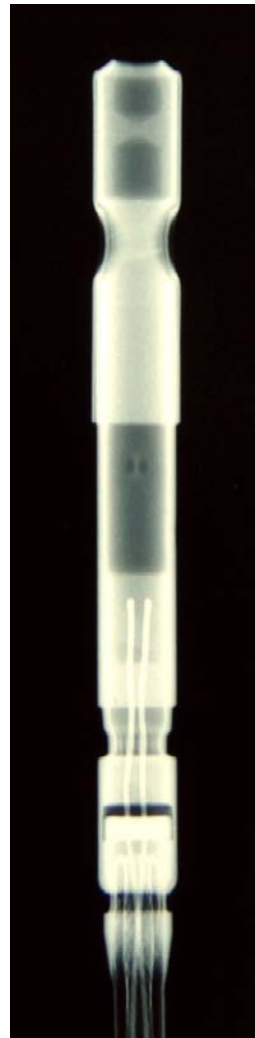
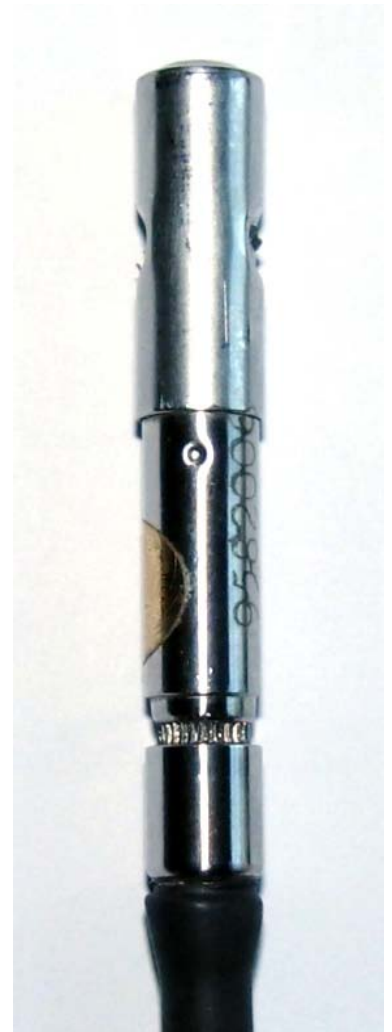
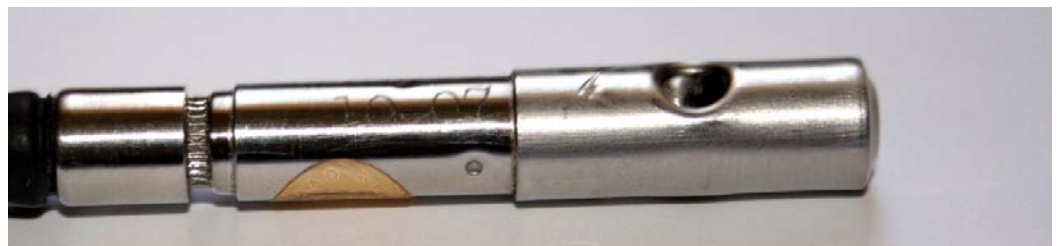
**Figure 1**

The cutter in the Vigil unit S/N 11258 was produced in October 2007 (only a lot of 299 cutters) and thus before the extra quality control with X-ray photos.

The two X-ray photos on **figure 1** show a comparison of the two cutters. On the left side of the figure we see an X-ray of a cutter produced in November 2009; in the middle of the figure the cutter of unit S/N 11258 after jump 288 that we have photographed. For the clearness we have added a normal photo of the cutter right on **figure 1**. On the bottom of **figure 1** we have added a second normal photo showing the DOM number (Date of Manufacturing): 10-07 or October 2007.

**On the X-ray photo of the cutter of S/N 11258 we can see that the cutter knife is missing.**

**In the meanwhile, it is absolute necessary that A.A.D. nv/sa performs a recall action of the 283 (299 – 16) cutters still in the field which were produced in October 2007.**
