PARACHUTES AUSTRALIA

SERVICE BULLETIN No PA SB98/01

SUBJECT: '94 TALON MAIN CONTAINER CLOSING LOOP POSITION

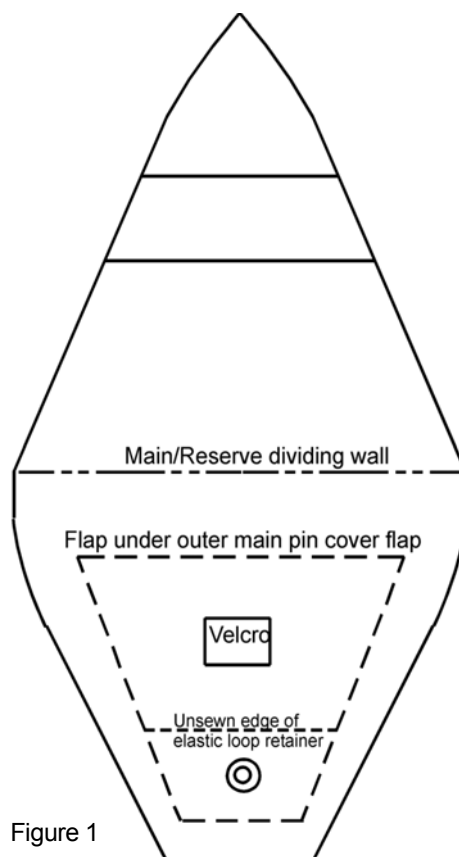
Figure 1

BACKGROUND: '94 Talon systems manufactured by Parachutes Australia between the above dates had a type 12 webbing main closing loop retainer mounted on the main/reserve dividing wall. After an incident on a Vector 2 system with a similar loop mounting system, new position for the loop was located from the smaller, under #2 pin cover flap. From D.O.M. January 1997 onwards '94 Talons have been manufactured with the new loop placement. Talon 2 systems are also unaffected

MANUFACTURER ADVISORY: PA strongly recommends that the loop position be changed from the main/reserve dividing wall to the new position. A 40mm wide elastic retainer is sewn to the under side of the flap to hold the loop after deployment. The loop retainer is placed over the "0" grommet and sewn on 3 sides into the binding tape leaving one side open where indicated for changing the closing loop .

Remove the previous loop retainer after unpicking the first row of stitching that attaches it onto the main/reserve dividing wall and heat seal to prevent fraying. This may be completed by an APF Packer A or foreign equivalent.

See diagram 1. of the new loop positions of the closing loop and elastic loop retainer.
