## **Paratec Investigation Report and official Statement to BPA Safety Information Ref : Next Tandem 3 Ring Failure 3/05**

Issue Date : 29-09-2005

Subject : Next Tandem Riser Incident on Sept. 18th, Hibaldstow DZ, UK

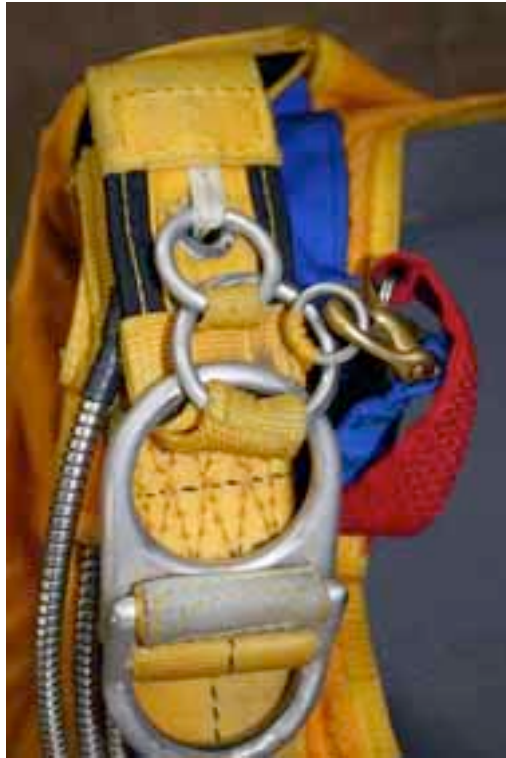
Picture No 1

Viewing the video of this jump, it was noticed that the RSL ring was led through the middle 3 Ring (large ring on the riser) from the back and re-connected with the snap shackle. (see picture No 1)  
This caused the 3 Ring System to be by-passed and the middle ring to be canted forward by the RSL ring for it to brake. This configuration again led to the shearing off of the Type I webbing holding the RSL ring, (see picture No 2) disconnecting it from the riser, which explains the immobilisation of said RSL, which was found in a untouched, still velcroed fully to the yoke, after the Tandem Pair had landed safely under Reserve. (see picture No 3)  
Picture No 4 shows the marks on the large ring created by the canted, overloaded middle ring before braking

We urge the organisations stated in the distribution of this document to inform all Tandem Instructors/Masters, Riggers, and CCIs within their area of authority and responsibility, to make them aware of this and for further prevention to make it a part of their personal gear check, during assembly, final inspection and general gear checks on the DZ.

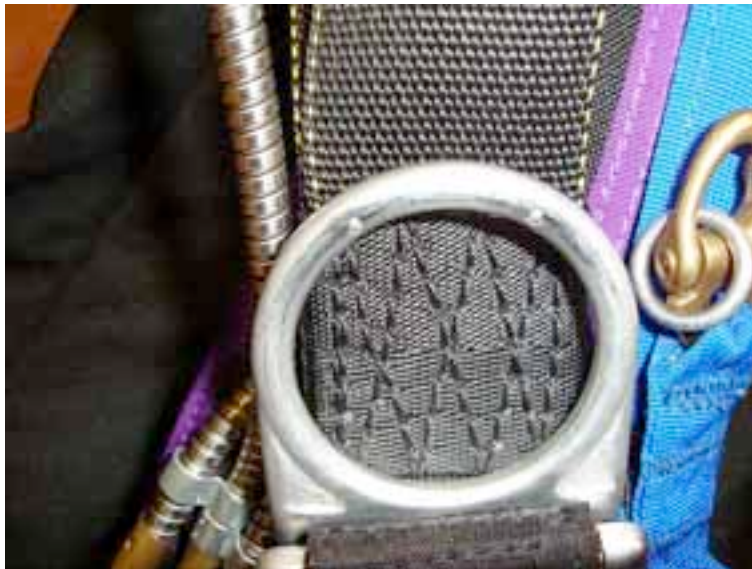
Picture No 4

When taking the logical course of said RSL system in conjunction with the working of the 3 Ring system and the result of the incident into consideration, it is clear that just before the middle ring broke, it sheared off the RSL ring, which then led to an overload of the small ring and the locking loop which then broke to release the riser.
