Doc.-No.: SB-O-200501 Date: 18.07.2005

SERVICE BULLETIN

Affected Equipment: Omega Container-System XXS, XS, S, SS, M, L und XL

Reason: One or more Lines were entangled with main container flap No. 2

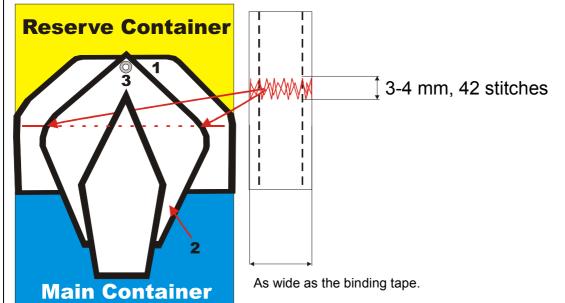
Bartec specification see drawing below!

Use only Typ E / 40, Nylon Bonded thread!

- 1. Mark out horizontal above the attachment of flap No. 3.
- 2. Put the grommets congruent on each other.
- 3. Apply a bartec (left and right) on the binding tape of flap No. 3 in the same height as the horizontal marking.
