AERAZUR 2 rue Maurice Mallet 92130 Issy les Moulineaux Tél. 33 1 41 23 23 23 Fax 33 1 46 48 83 41	<h2>Service Bulletin</h2> <p>Title : Improvement of the Harness/container Titre: amélioration des sacs/harnais biplaces</p>	BS-25-63-34 Date: 31/07/2007 Page 1/8
--	--	---

Block 1	<u>Technical Background</u>	
a)	Applicability	: <u>Dual harness/containers</u> : 740-1 (ATOM TANDEM) and MMS 740-2 manufactured before 2002 as presented in page 2.

b)	Reason	: Packing procedure not correctly applied and improvement of the center flap design.
c)	Description	: During a tandem jump a main canopy line has been caught under the center flap in the configuration: <ul style="list-style-type: none"> ➤ Improperly packing process: The elastic band was not inserted through the lateral grommets of the POD. In this configuration, at the extraction of the POD out of the container, some lines can be extracted from the elastic band and fly close to the center flap. ➤ The drogue was released during the rotation of the jumpers. Background demonstrates that this configuration can appear again, the improvement of the center flap will reduce the risk of blocking.

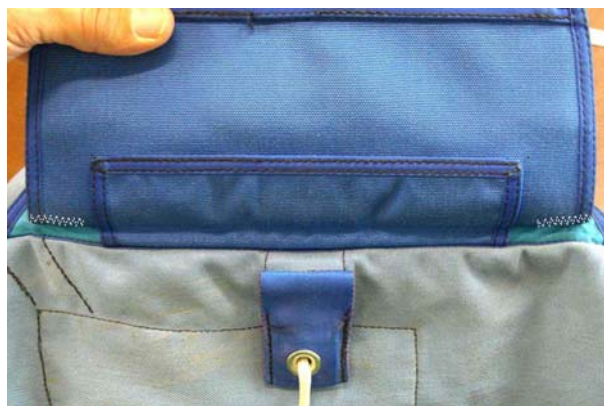
Inside the first generation main container (stitching hidden)
