SERVICE BULLETIN VSESB001

DATE: June 1, 2013

SUBJECT: MAIN RISER, LOCKING LOOP WEAR

STATUS: MANDATORY INSPECTION

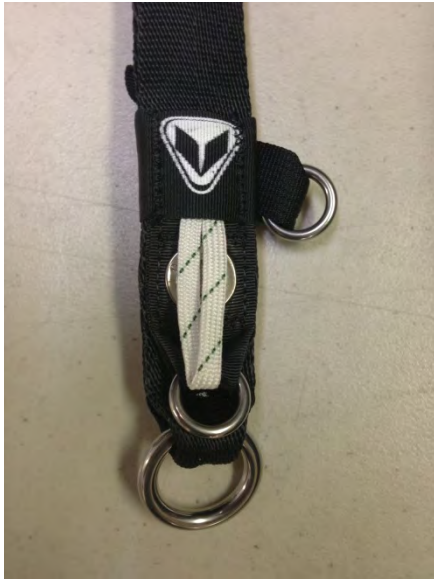
Figure 3: New Locking Loop

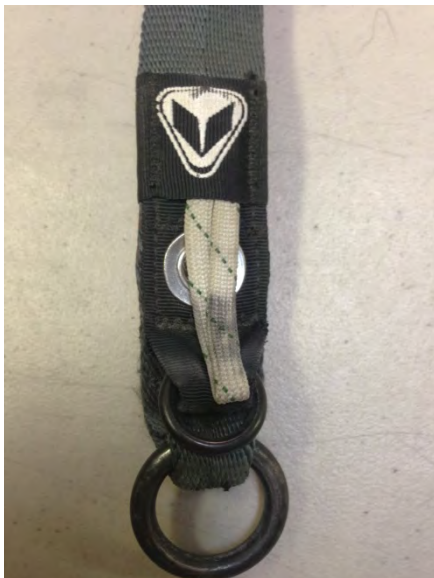
Figure 3: Normal Wear, Front

If the loop shows normal wear, the rig can continue to be jumped and no immediate repair is needed.

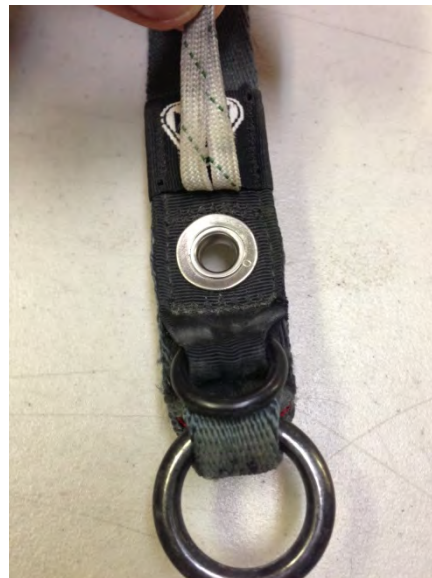
Figure 4: Normal Wear, Back

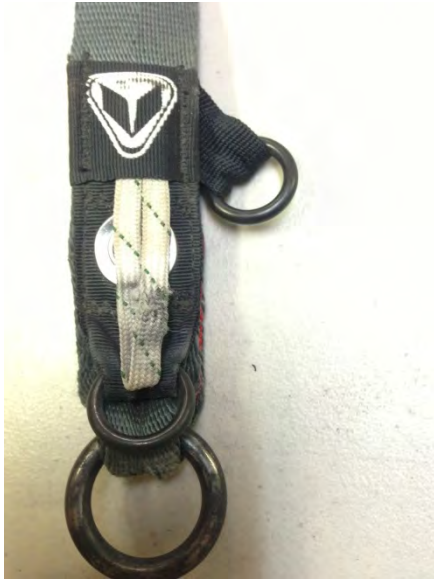
Figure 5: Damaged, Frayed

If the loop shows signs of damage, the rig should not be jumped and VSE should be contacted for further instructions. VSE may also ask for additional information to help determine the root cause and most effective repair. At minimum, VSE will need 2-4 photos, one of each riser loop and one of each housing grommet. Please have these available to send to VSE when you call in. In most cases, once the root cause is determined, VSE will provide a parts kit which can be installed by an FAA certified senior or master parachute rigger or foreign equivalent using the Housing Replacement Procedure provided at the end of this service bulletin. In certain cases, VSE will require the rig be returned to VSE for further inspection and repair.

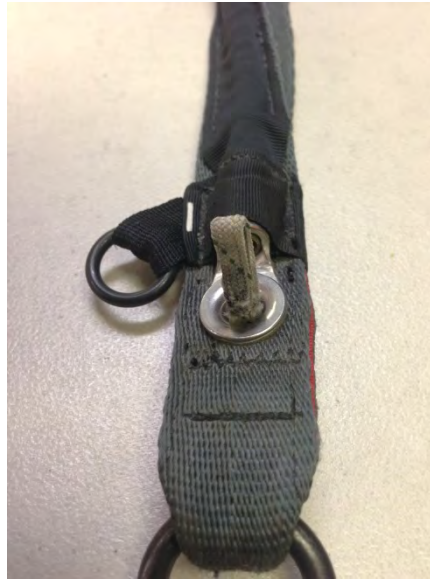
Figure 6: Damaged, Frayed

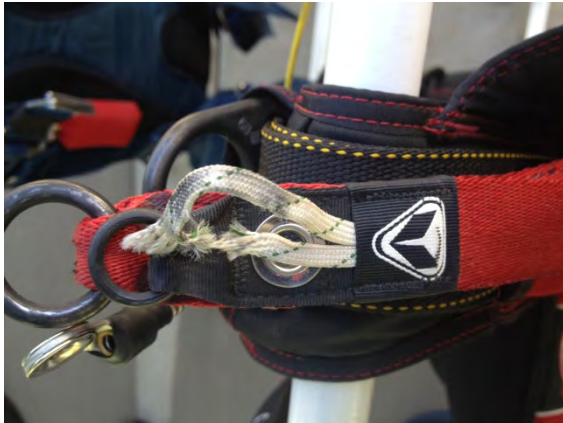
Figure 9: Damaged, Partially Cut

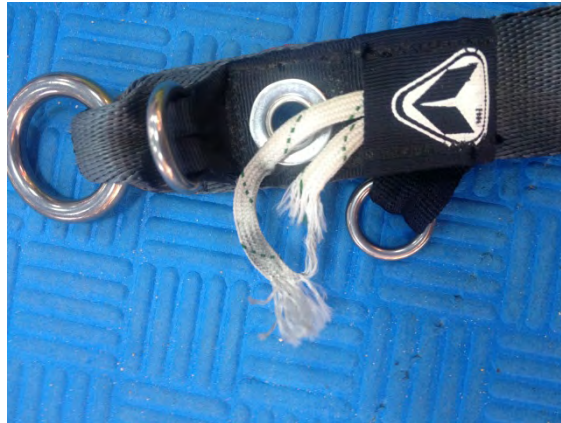
Figure 10: Damaged, Partially Cut
