Equipments affected :

FLEXPACK Harness-container (P/N 8002012200).
FLEXPACK Harness-container (P/N 80020130 or 8002013000)

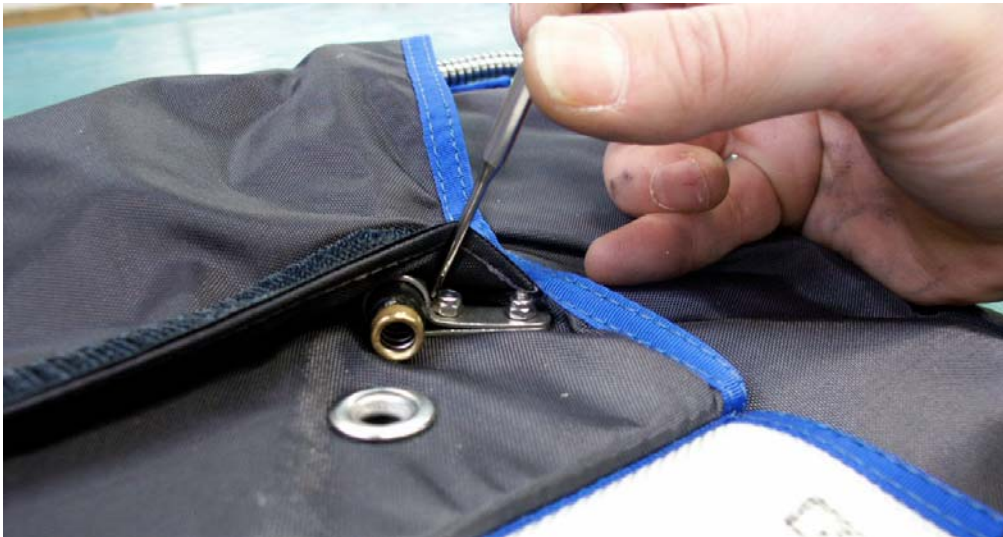
Picture 1

Disconnection between the metallic housing of the activating cable and its fixing collar (on pin side) as a result of the loosening of the collar screws.

The fixing collar must be tightly screwed on so that the metallic housing may not move (Picture 1).

In case the metallic housing moves :

- Remove the nuts (NYLSTOP inox nut - 3mm in diameter)
- replace them by new ones
- Screw them on tightly but not too much.
