### Technical Service Bulletin

Bulletin No :        TSB – PT 080904

Subject :            Reserve Ripcord Pin with **round swaging** of Single Reserve  
Harness/Container System

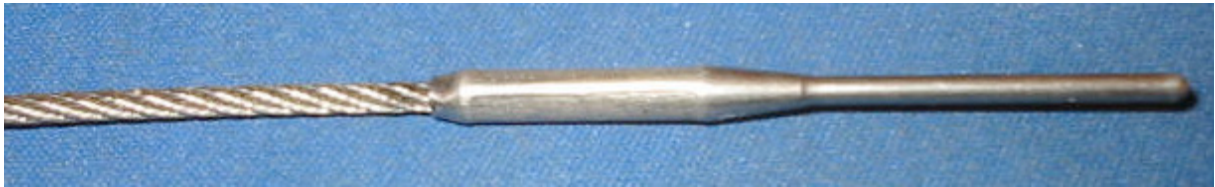
The Batch number is TSE 1 PTD 5141A, stamped in the handle, the pins can be identified by a visual inspection of the swaging, rounded on this batch instead of “crimped” like most other pins.

**AFFECTED** : Round swaged pin

- Identification of ripcord, installed or stored as spare part.
- In case of rounded swaging, re testing according to AS 8015 Rev.B, 4.3.1
- In case of failure, grounding of ripcord, contact manufacturer for replacement part
- In case of compliance, dot marking of pin with red waterproof marker and log in packing data card

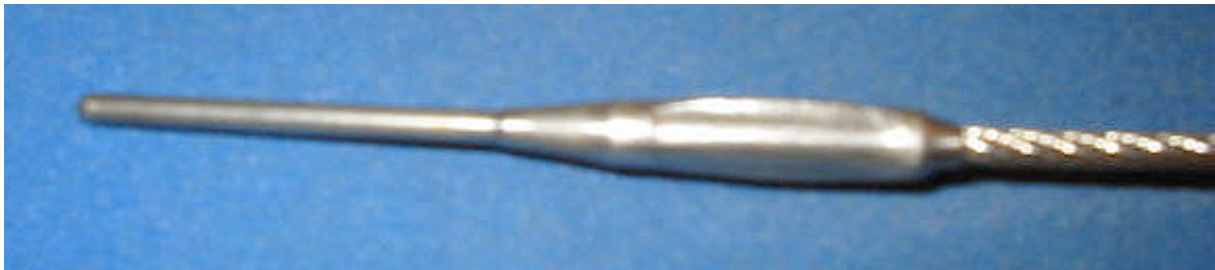
**NOT AFFECTED** : Flat swaged or crimped pin.
