ALTICO SERVICE BULLETIN

#ASB 060700

SUBJECT: STIFFENER IN TOP FLAP OF DOLPHIN MAIN CONTAINER

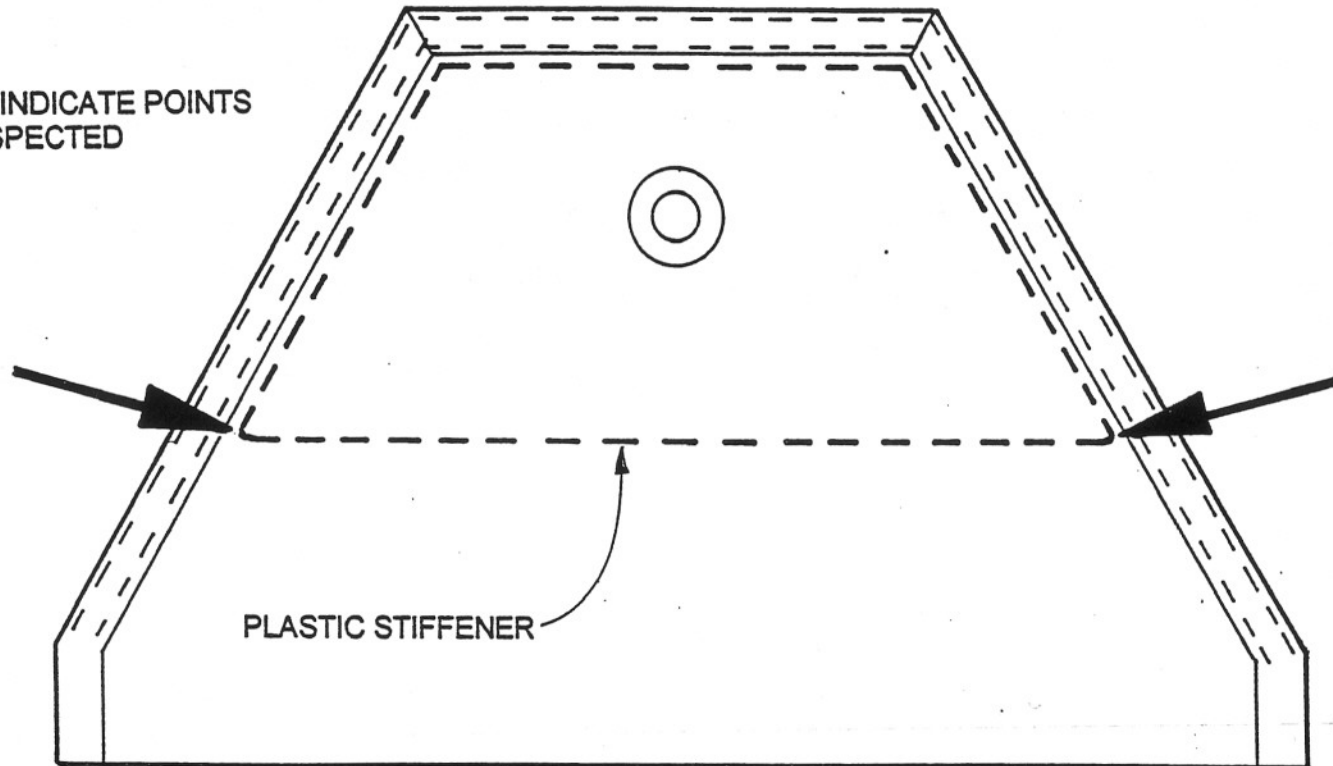
FIG. 1

On the underside of the top flap of the main container, the corners of an unreinforced stiffener may wear through the fabric covering. Although this condition may easily escape notice during normal repacking, the exposed corner can catch a suspension line, producing a horseshoe malfunction. One such incident was reported in December of 1999, with the reserve fortunately deploying through the malfunctioned main which remained caught by a suspension line after a cutaway had been attempted. In May 2000 a report was received that a rigger had noticed this condition during a routine inspection/repack, and the exposed corner was covered prior to the next jump.

ARROWS INDICATE POINTS
TO BE INSPECTED

UNDERSIDE OF MAIN TOP FLAP

- 1) Inspect underside of main top flap at points indicated in FIG. 1.
If a corner of the plastic stiffener is exposed by wear, proceed with Step 2.
- 2) With a hot knife, cut a piece of 1" Type IV tape as shown in FIG. 2.
- 3) Remove the stitches from a 1-3/4" (approx.) section of binding tape along each side of the main top flap. The section of removed stitches must be centered on the edge of the stiffener as shown in FIG. 3. This is done so that the ends of the reinforcing tape may be installed under the binding tape.
- 4) Center the prepared piece of 1" Type 4 tape over the edge of the stiffener and stitch as shown in FIG. 4.
- 5) Replace the stitching in the binding, covering the ends of the Type IV reinforcing tape and oversewing approx. 1" on each side.

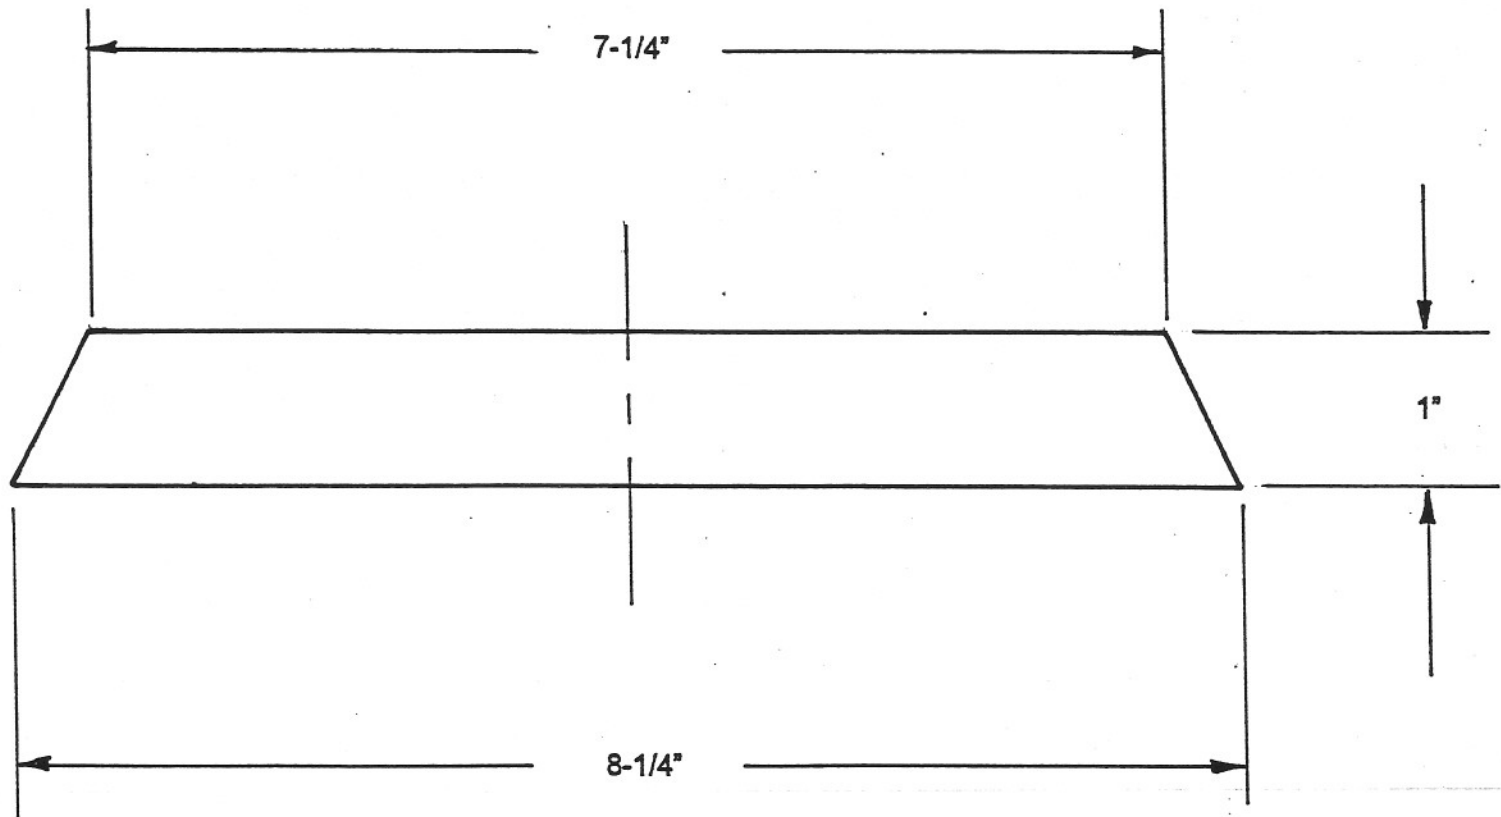
FIG. 2

TYPE IV REINFORCING TAPE
