AUSTRALIAN PARACHUTE FEDERATION

APF SERVICE BULLETIN N^o. APF 100427 Issued 27 APRIL 2010

SUBJECT: RIPCORDER PIN TEST

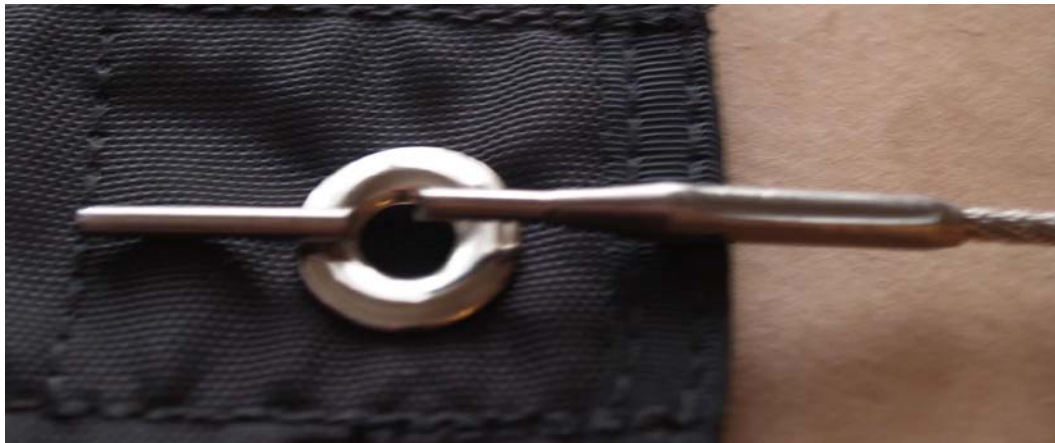
BACKGROUND: A reserve being closed after repack had the terminal pin of the ripcorder break as it was inserted into the closing loop. The rigger had closely inspected the pin prior to attempting to insert it and it was straight without any visible defect. The pin fractured 0.40" (10mm) from the shoulder at the place where the CYPRES closing loop would sit. The rig, a PA Talon was manufactured in 07/ 96 and the ripcorder was unmarked and presumed to be original as no other data was available on the log card to indicate otherwise. The ripcorder is outside the date period as noted in [Capewell SB No. CW03-01](#) and there are no indications that it may have been previously tested.

Pic 1. Broken pin shown over "0" grommet

APF ADVISORY: That all reserve ripcords in rigs manufactured before July 2003 that do not have manufacturer's data or test indications on them be subjected to [Capewell Service Bulletin CW03-01](#) **Field Test 1** and marked as indicated in the SB.

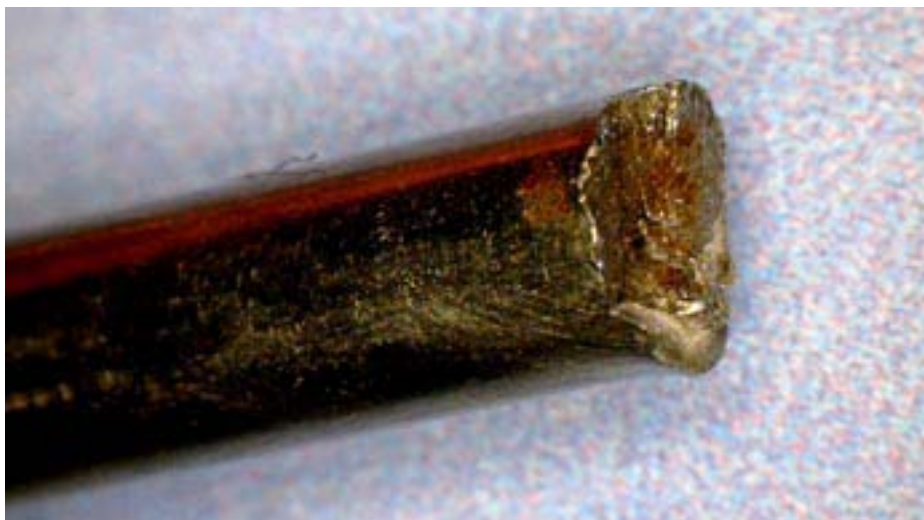
Pic 2. Broken body end of pin magnified.

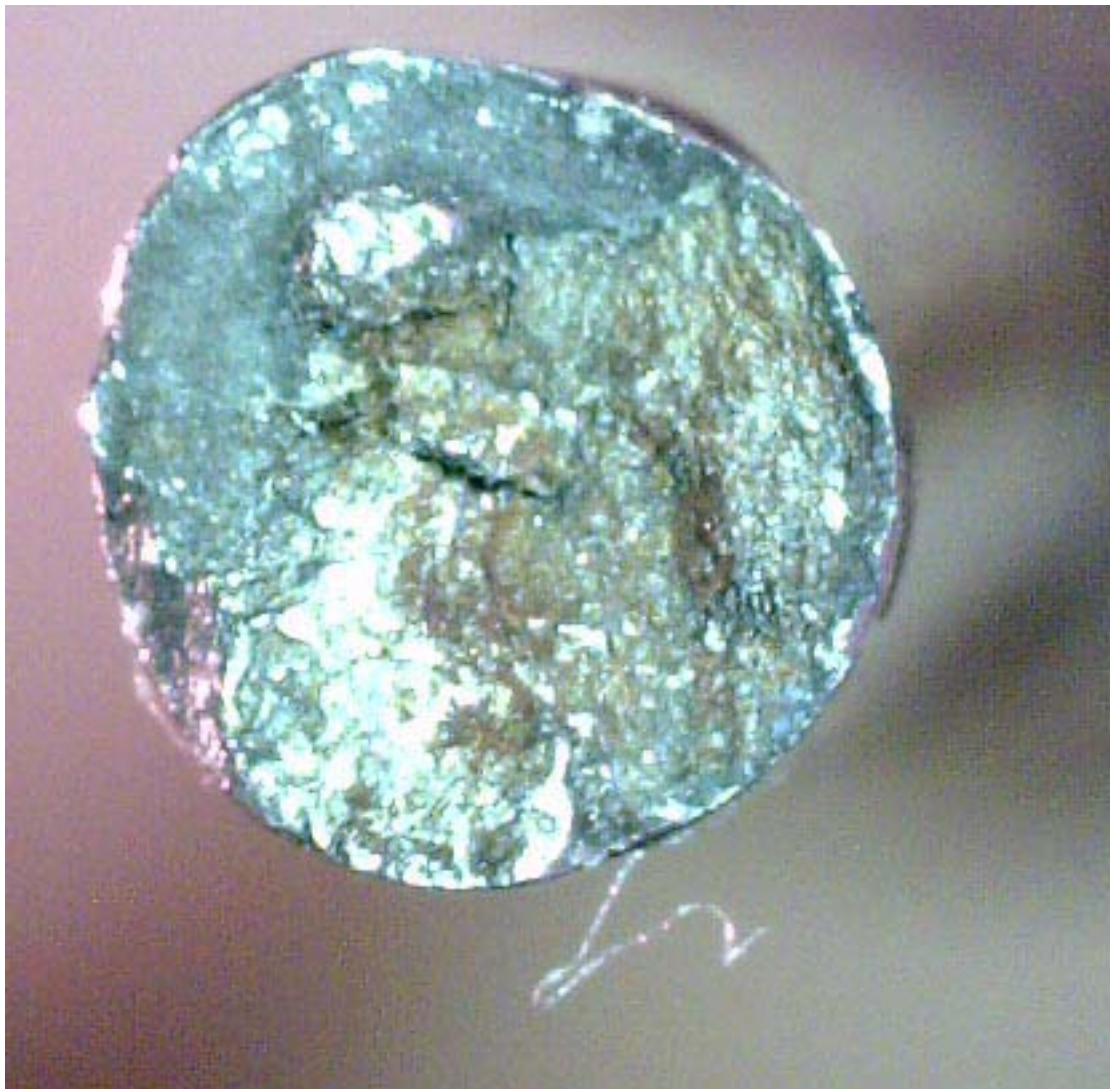
Pic. 3. Face of fracture, body side of pin. Brown discoloration on face may be corrosion or an impurity in the stainless steel. (The ripcord has been returned to the manufacturer for further analysis).

The location of the break is such that if it had been tested according to [Capewell SB CW03-01](#) test 2 it may have passed the test as the fulcrum point in this test is 0.188 from the shoulder and is above the break. Test 1, an in the field in situ test on a packed rig would be an appropriate test as the load would be applied at a point consistent with the seating of the closing loop.

As test 2 may not be an adequate test due to the fulcrum point being too close to the shoulder an alternate test as described in Poynter's "the Parachute Manual" Vol. 2, Chapter 6.15. Inspection and Testing, where the pin tip is inserted ½" (12.5mm) into the test block and a load of 8lb is applied at right angles in four equispaced directions. This will test a greater length of the pin blade. The ripcord handle should then be permanently marked "APF-T2". The log card should also be annotated with the date and APF SB No.100427- T2.
