AUSTRALIAN PARACHUTE FEDERATION

APF SERVICE BULLETIN No APF981001-A

SUBJECT: MAIN CONTAINER CLOSING LOOP GROMMET

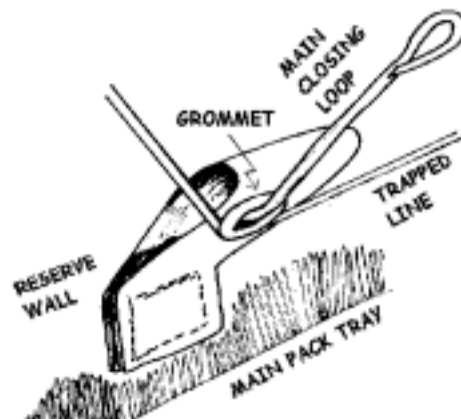
BACKGROUND: There have now been two incidents in Australia one on a Talon and one a Vector (and one in the USA on a Mirage) where a main canopy rigging line has hooked under the edge of the grommet and resulted in a main-in-tow despite being cut away. In both Australian cases the reserve was used and cleared the main.

There are a number of other brands of equipment manufactured this way, some with the grommet facing the reserve wall, some with the grommet facing the main bag that could be susceptible to this.

APF POLICY: The APF requires all dual container systems incorporating a grommet on a webbing retainer facing the main bag, in order of preference, to:

1. have the retainer with grommet removed and the loop fixed to a closing flap grommet, or
2. have the retainer turned over or have the grommet removed and installed the other way (facing the reserve), or
3. have the grommet covered by sewing a piece of material around 3 sides of the grommet face.
