TECHNICAL & SAFETY COMMITTEE

INTERNATIONAL PARACHUTING COMMISSION (FAI)

<p>Technical & Safety Information Notice No.</p>	<p>06/2011 Virgil AAD</p> <p>W.N. 41</p> <p>Note – This Information Notice supersedes IN 05/2011, W.N.40, issued 06 Oct. 2011.</p>
<p>Date of Issue</p>	<p>23 October 2011</p>
<p>Subject Matter and Applicability</p>	<p>VIGIL AAD CUTTERS EMERGENCY PRODUCT SERVICE BULLETIN # PSB-8 (Supersedes Product Service Bulletin PSB-7)</p> <p>SUBJECT: Vigil AAD, All Cutters produced in October 2007 Part Number: 9582006 Date of Manufacture: 10-07 (mm-yy) (see Photo 1)</p>
<p>Background Information</p>	<p>BACKGROUND: This SB-8 revises SB-7 to include additional serial numbers (see list B) and to add additional guidance for compliance requirements. The following incident occurred on the 14th September 2011 at the Saint-Jean Chrysostome (Canada) drop zone: A skydiver failed to deploy his main canopy and manually pulled his reserve handle with insufficient altitude to fully deploy the reserve canopy. During the investigation of the incident it was discovered that the loop was neither cut nor trapped by the cutter.</p>

**A.A. A.A.D. nv/sa
VIGIL Unit S/N 11258 – Jump 288
Preliminar

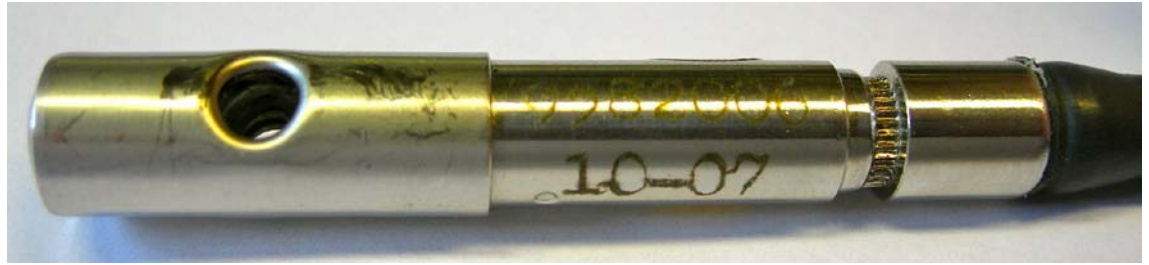
Photo 1

DOM : October 2007

Therefore, verification of the Date of Manufacture (“DOM”) of the cutter must be performed at the time of the next reserve repack. **Every cutter found with a DOM of 10-07** (see Photo 1) **must be replaced before the next jump, and the cutter which was removed must be returned to Vigil.** (Please contact AAD sa/nv or Vigil USA, LLC for return information and instructions).

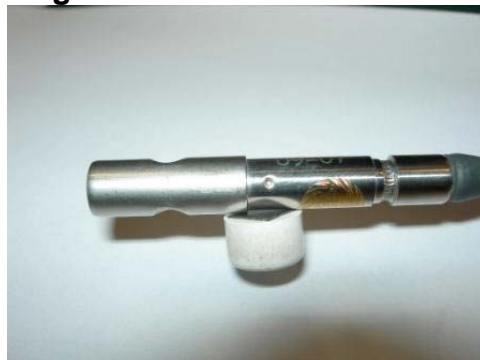
In the interest of additional safety, we have devised a field test, which can be performed on any Vigil cutter, using a magnet to confirm the presence or lack of a knife blade. It can be done using any magnet on any cutter. Either a small (see Photo 2A) or a larger (see Photo 2B) magnet may be used. You must ensure that the magnet is placed directly below the closing loop hole portion of the cutter, as shown in Photos 2A and 2B. If there is a knife blade present, the magnet will be attracted to the knife blade. If you require a magnet they are available on request from AAD sa/nv or Vigil USA, LLC.

Note: All Cutters manufactured from June 2008 have been x-rayed as part of our quality control process, and we have confirmed that the knife blade is present, however for additional safety, we highly recommend that the magnet test be performed on each cutter manufactured prior to June 2008.

Once compliance with this bulletin has been met, and, if necessary, the 10-07 cutter has been replaced, or a cutter with a manufacture date prior to 06-08 has been tested with a magnet and it has been determined that a cutter is present, or it has been determined that the cutter DOM is 06-08 or later, the reserve parachute packing data card should be marked with “Vigil SB-8 - OK.”Magnet Test Procedure

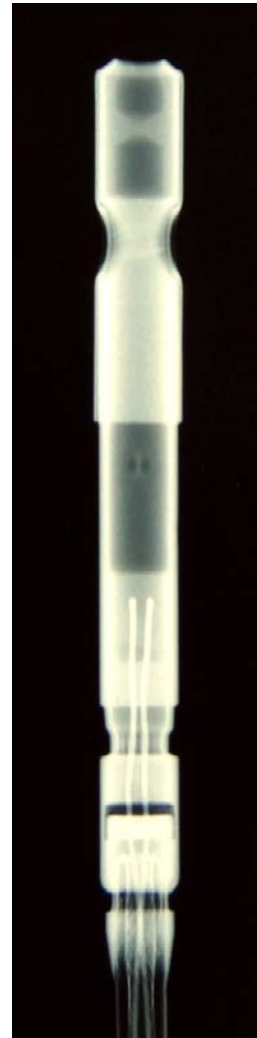
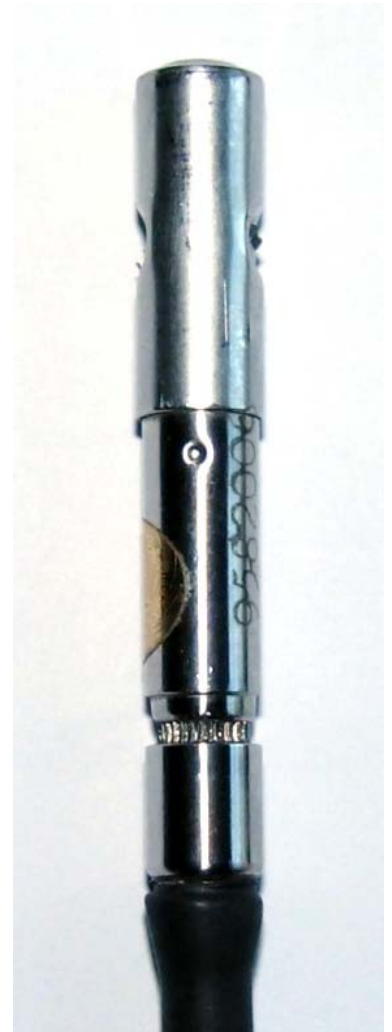
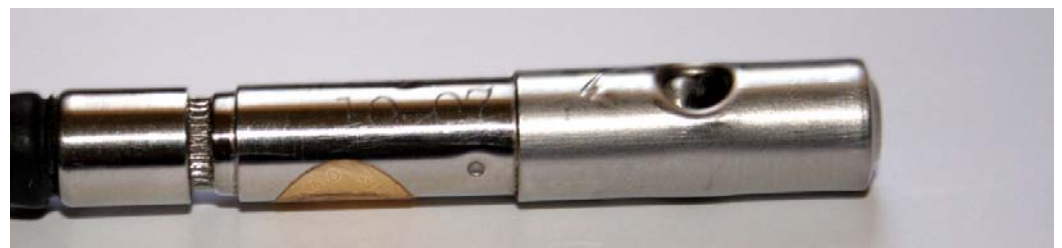
Figure 1

The two X-ray photos on **figure 1** show a comparison of the two cutters. On the left side of the figure we see an X-ray of a cutter produced in November 2009; in the middle of the figure the cutter of unit S/N 11258 after jump 288 that we have photographed. For the clearness we have added a normal photo of the cutter right on **figure 1**. On the bottom of **figure 1** we have added a second normal photo showing the DOM number (Date of Manufacturing): 10-07 or October 2007.

On the left X-ray photo we can clearly distinguish the different parts of the cutter:

- the anvil on the top for the energy absorption of the cutting knife;
- the loop hole;
- the cutter knife;
- the fuse (igniter) with the powder for the pressure generation;
- sealing-crimp
- Kevlar cable lock-pen

On the X-ray photo of the cutter of S/N 11258 we can see that the cutter knife is missing.

Cutter Nov 2009

Cutter of unit S/N 11258 after jump 288 (Part Number 9582006)

Date of Manufacturing (DOM): 10 - 07

The cutter in the Vigil unit S/N 11258 was produced in October 2007 (only a lot of 299 cutters) and thus before the extra quality control with X-ray photos.

However, we can compare a cutters X-ray of November 2009 with the received cutter of unit S/N 11258 that we have photographed. There are no changes in the design between October 2007 and November 2009.

We have also performed a firing test on 15 cutters from that same production batch. All those cutters performed correctly to specifications and cut the loop without tension.
