SERVICE BULLETIN No. 11/09/2010

Check of Ripcord Handle Pins

Photos of ripcord handle and ripcord pins

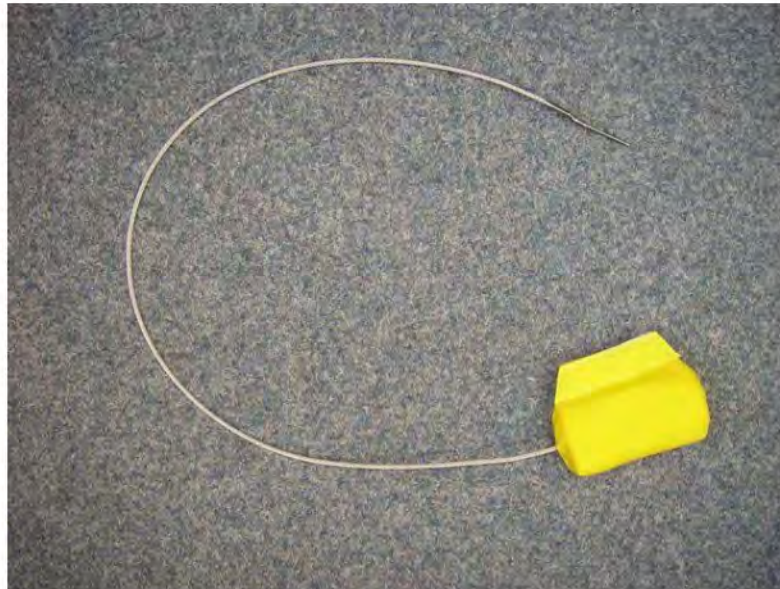
Pic. 1
Ripcord Handle U-064

- 1. APPLIESTO:** the pins of ripcord handle reserve parachutes U – 064 (pic.1), U – 051 (pic.2) and U – 069 (pic.3), produced by Synek company (pressed pins – hexagonal press, see pic. 4 A - straight and pic. 4 B - bent), which are parts of:

- 3. MEASURES:**
- A user or a packer licensed to pack the reserve parachutes (authorized person) proceeds a check of the ripcord handle pin at the products mentioned in part 1 and in case the pin body is found damaged, he/she puts the parachute set out of service.

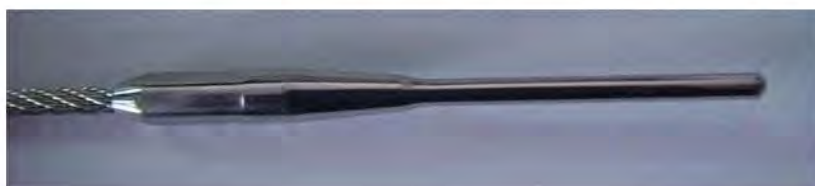
Service bulletin **refers to** these pins:

Pic. 4 A
Pressed pin – straight, hexagonal press (e.g. the press at the line has the hexagonal shape)

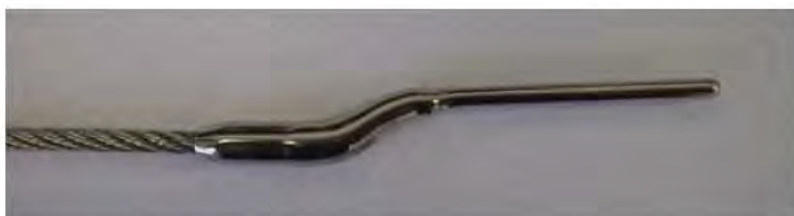
Pic. 4 B
Pressed pin – bent, hexagonal press

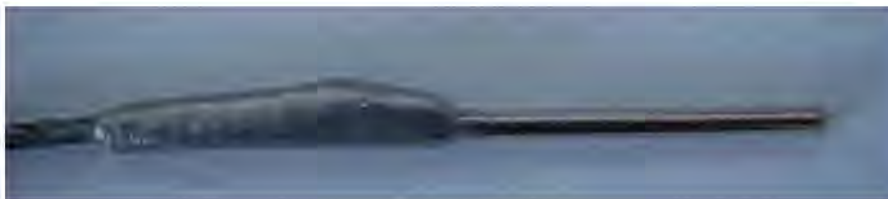
- soldered, see pic. 5
- pressed USA (flat press), see pic. 6.

Service bulletin **does not refer** to these pins:

Pic. 5
Soldered pin

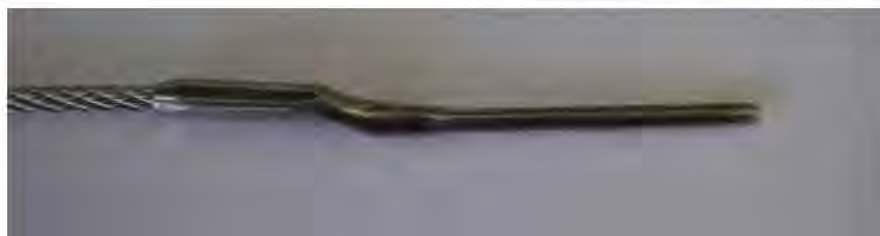
Pic. 6
Pressed pin USA, flat press (e.g. the press at the line is flat)
