Service Bulletin **SP03 – Adjustable Main Lift Web Harnesses**

Issued July 19, 2004

Javelin Student and Student Odyssey with Adjustable Main Lift Webs.

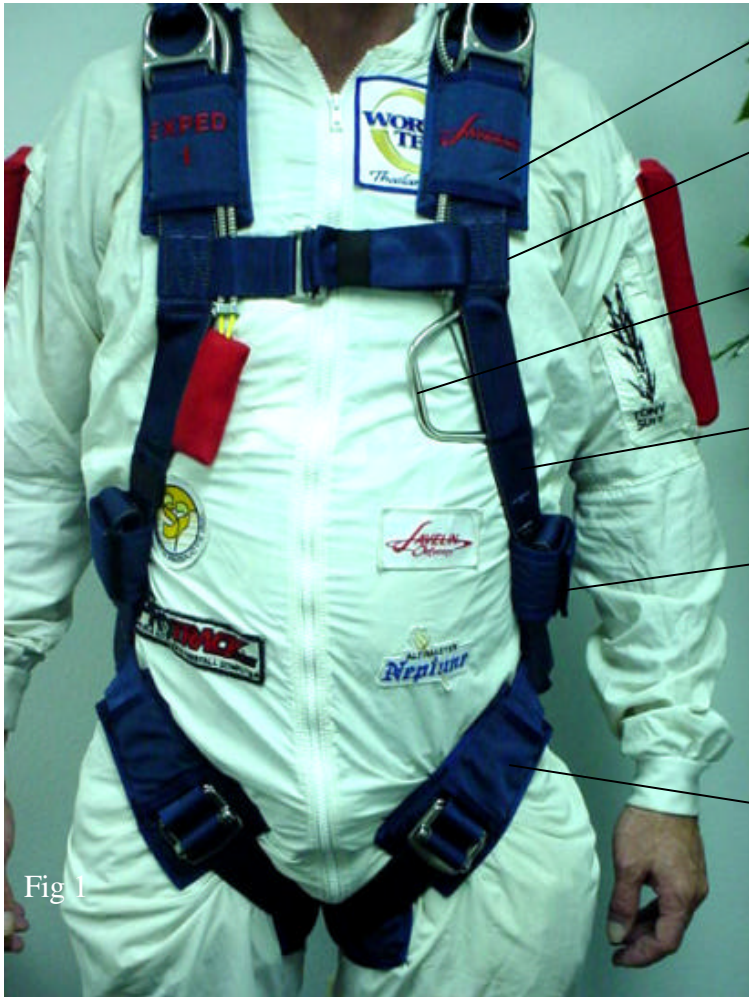
Fig 1

LRC - Left Ring Cover

Cheststrap

Reserve Ripcord Handle

Main Adjustable Lift Web - Left

Main Lift Web Adjuster under Cover Refer to Fig E1 below for Detail

Legstrap Left

Javelin Student and Student Odyssey with Adjustable Main Lift Webs. See Fig 1. TSO Label Identification as per - Part No 101 A-ADJ, B-ADJ or C-ADJ, see Fig 2. All dates of manufacture up to and including July 19, 2004 are affected.

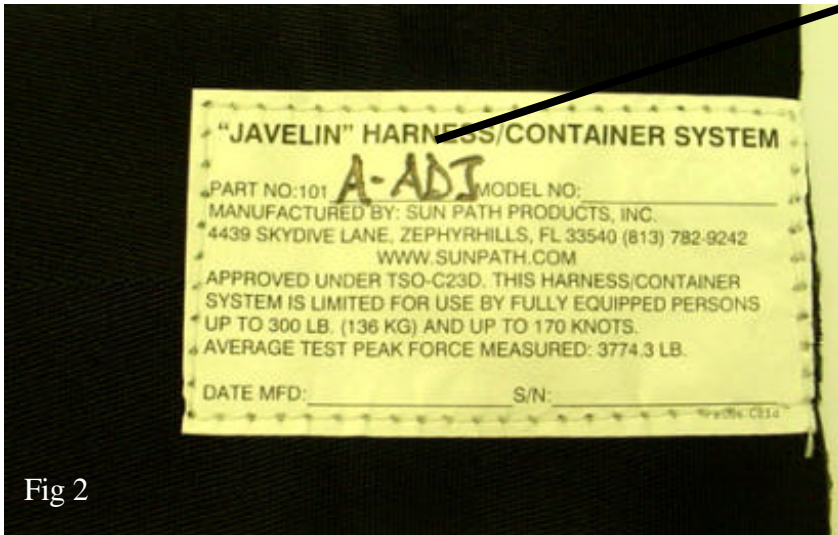
Fig 2

Part Number

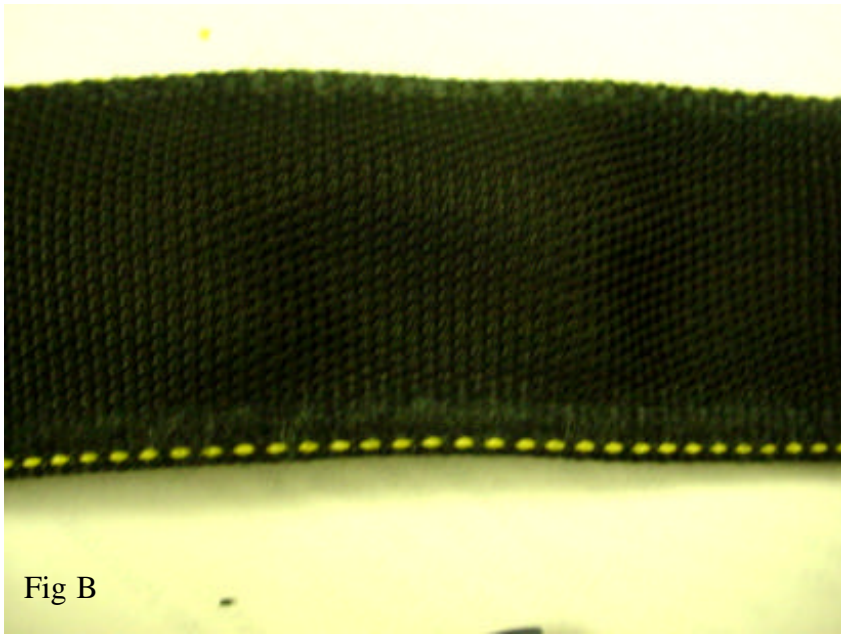
Fig B

Grade 2

- “1” - Like New – see fig A.
- “2” – Minor Hook & Loop type abrasion. Minor abrasion from normal use similar to that of legstrap webbing through a friction adapter – see fig B.
- “3” – Any selvage damage at all to any harness webbing - see fig C.
Missing or broken harness stitching - see fig D.
Any loosening or stretching of the lower connection point webbing which would allow the friction adapter to rotate – see fig E1 & E2.
Any damaged hardware, sharp edges or other deformities that may be considered a cause for the damage in this grade level.

- (c) If the finding of the inspection in paragraph (a) receives a grading of “1” or “2”, the Harness Inspection Record must be submitted to Sun Path Products, Inc. prior to the system being returned to service.

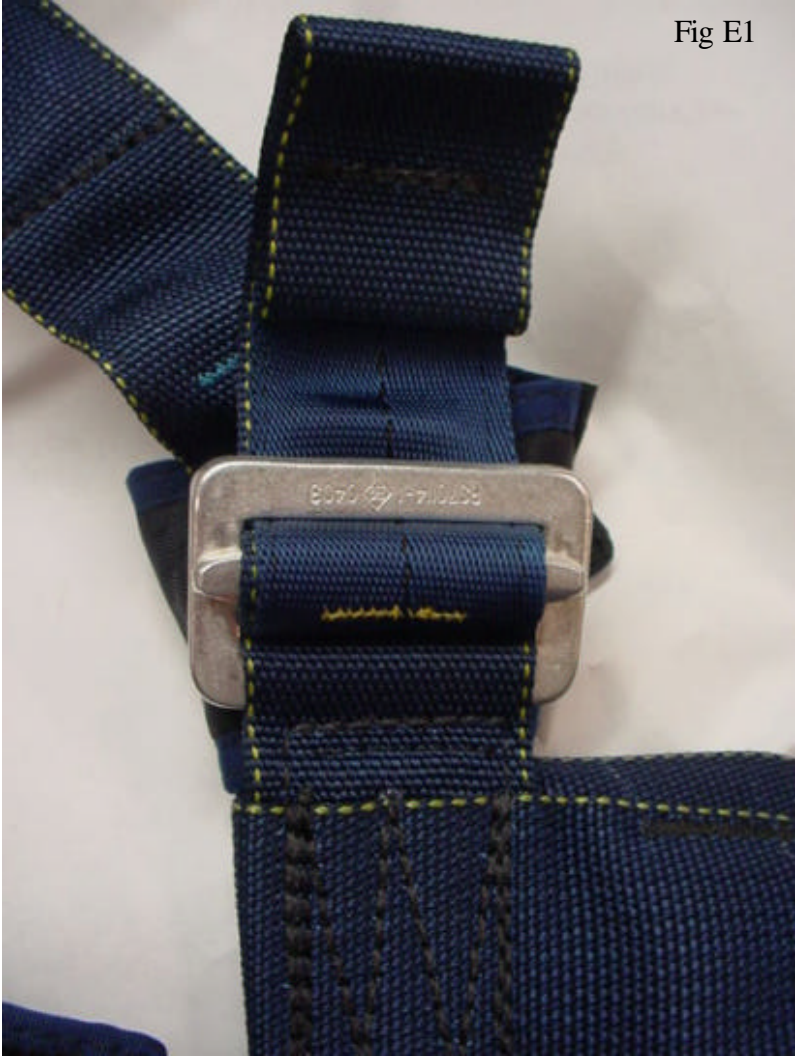
Fig E1

Grade 1- Hardware secured by webbing

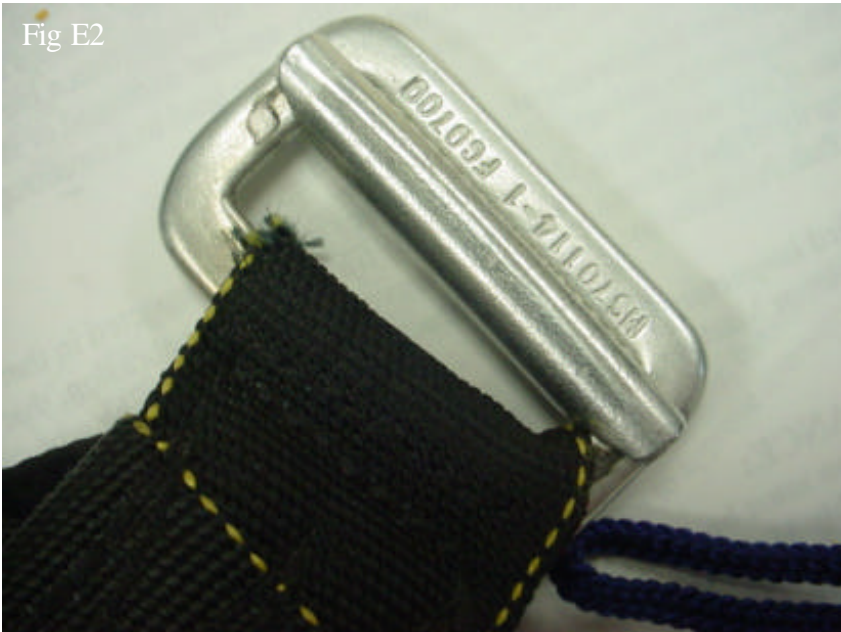
Fig E2

Grade 3 - Hardware able to rotate and/or selvedge damaged

- (d) If the finding of the inspection in paragraph (a) receives a grading of “3”, the harness/container system is to be removed from service immediately. The Harness Inspection Record must be submitted to Sun Path Products, Inc. prior to the affected harness sections and /or hardware pieces being replaced and the system re-certified airworthy.
