RIGGING ADVISORY CIRCULAR

RAC No. 427 Rev. A

SUBJECT: PARACHUTES DE FRANCE PRODUCT SERVICE BULLETINS

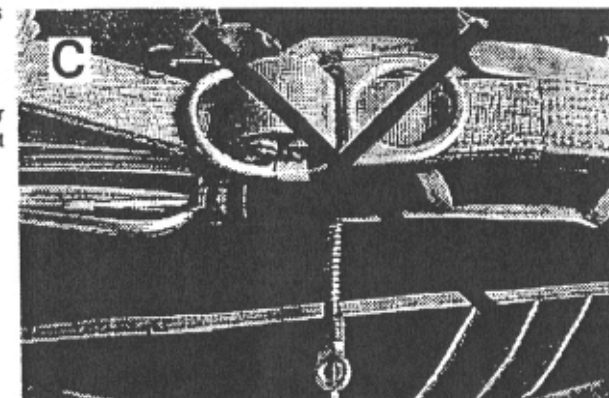
--> If you can freely move one housing relative to the other, this can seriously effect a break away operation, or even make it impossible. In this case, the JAGUAR must be returned to Parachutes de France for repair. Repairs are free of charge, except for return shipment.

- 4** Put in the new release housing and secure both release housings with two tackings on the Type 12 webbing.
