Doc.-No.: SB-O-200501 Date: 18.07.2005

SERVICE BULLETIN

Affected Equipment: Omega Container-System XXS, XS, S, SS, M, L und XL

Reason: One or more Lines were entangled with main container flap No. 2

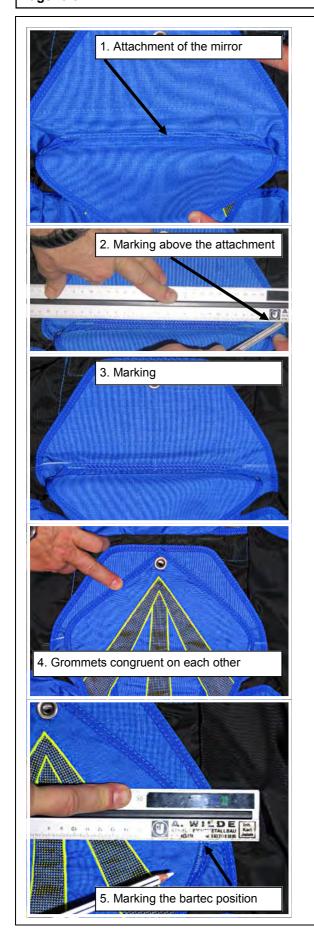
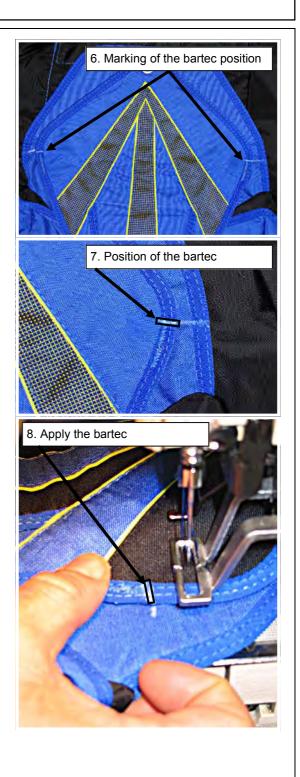
Analysis: A combination of a couple of facts can cause line entanglement with flap No.

Reasons for these failure can be:

1. Wrong size or old rubber bands.

2. To much not stowed or misplaced line length inside the main container.

3. Opening of the main container in slightly head up or stand up position.

Recommendations: a. Use only rubber bands in the right size.

b. Replace all rubber bands after 120 days or 50 jumps.

c. No not stowed line length longer than 40 cm.

d. Never place main risers and/or lines in a curve around the corners of the reserve container.

e. Horizontal, stable body position during pulling the hand deploy and the entire opening of the main parachute.

To avoid failure like written above and during improper use of the equipment in the future, the mirror (Flap No. 3 of the reserve container) must be sewed at the round corners with two short bartec to the flap No. 1 of the reserve container. This avoid contraction of the flap under tension while a line is tucked under. And it is easier to turn up the flap to release a line.
