## APF SERVICE BULLETIN No APF091110 Issued 10<sup>th</sup> November 2009

**SUBJECT:** Advanced Aerospace Designs (AAD) Vigil PSB-5

## **Product Service Bulletin**

**Bulletin Number:** PSB-5

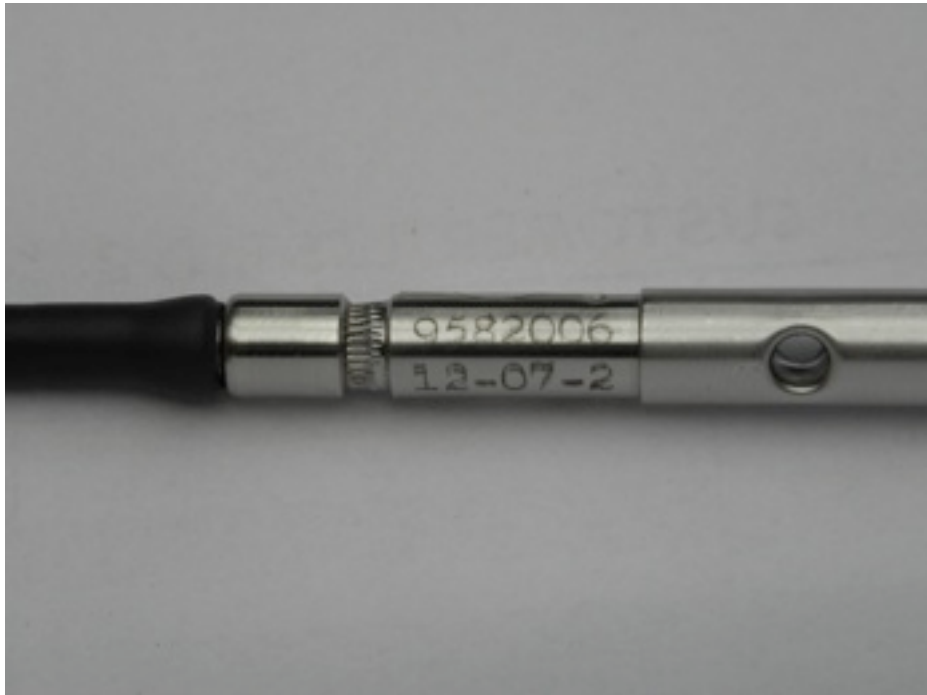
Picture 1

Vigil AAD, All Cutters produced in December 2007  
Part Number: 9582006  
Date of Manufacture: **12 - 07 - 2 (mm/yy/Batch)**  
See pict.

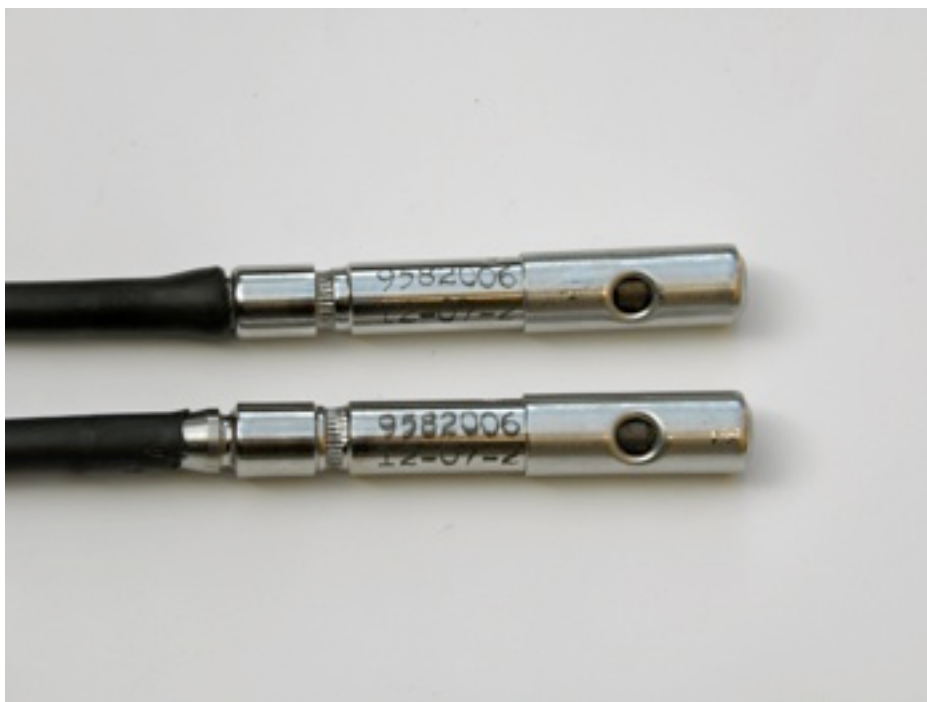
Picture 2

They want to confirm that 2 cutters of that batch were activated by them for test purpose and worked to specification. (See Vigil PSB-5 picture 2).

We want to confirm that 2 cutters of that batch were activated by us for test purpose and worked to specification. (See picture 2).
