# Manufacturer Product Service Bulletin

## Number CW03-01

**Subject:** Capewell Supplied Pins and Ripcords

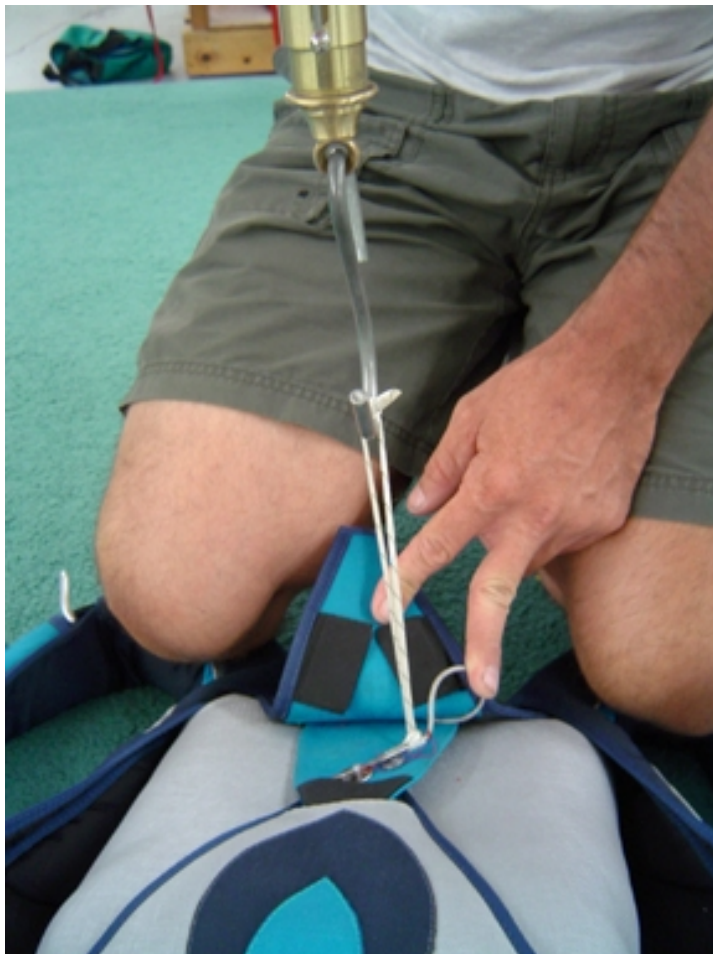
**FIGURE 2**

5. Secure the other end of the loop to the spring scale.
6. Apply a load of 15 lbs. (6.8kg) straight up and 90 degrees to the axis of the pin for a period of 3 seconds and then release the load (Fig. 2). Inspect the pin for any deformation or bend. If the pin is straight, continue with step 7 below. If the pin is not straight, as visible without magnification, remove the pin/ripcord from service immediately.
