COMMISSION SECURITE CIRCULAIRE DE SECURITE N° 170

Subject: Failure of drogue bridle connection between the drogue and the deployment bag at the time of drogue release.

Equipment concerned: Tandem Atom 740-1 of Parachutes of France-Aérazur

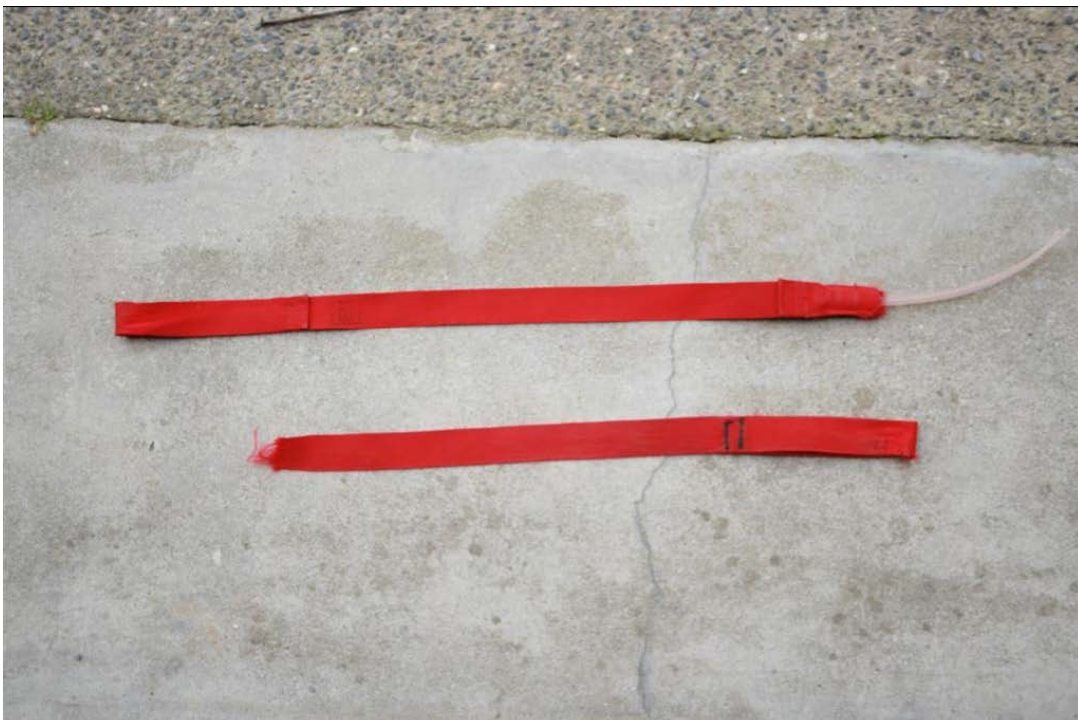
The CTP was alerted to several cases of failure of the bridle between the drogue and the deployment bag which occurred at the time of drogue release and the beginning of deployment. In all the cases, the opening was disorganised and the risk of interference between the main canopy and the tandem pair was very likely.

- failure of the bridle
- interruption of the deployment sequence
- failure of the deployment bag to lift and the suspension lines partially wrapped/tangled in the legs of the tandem couple
- lift-off of the main deployment bag only by its own drag
- a disorganised canopy opening

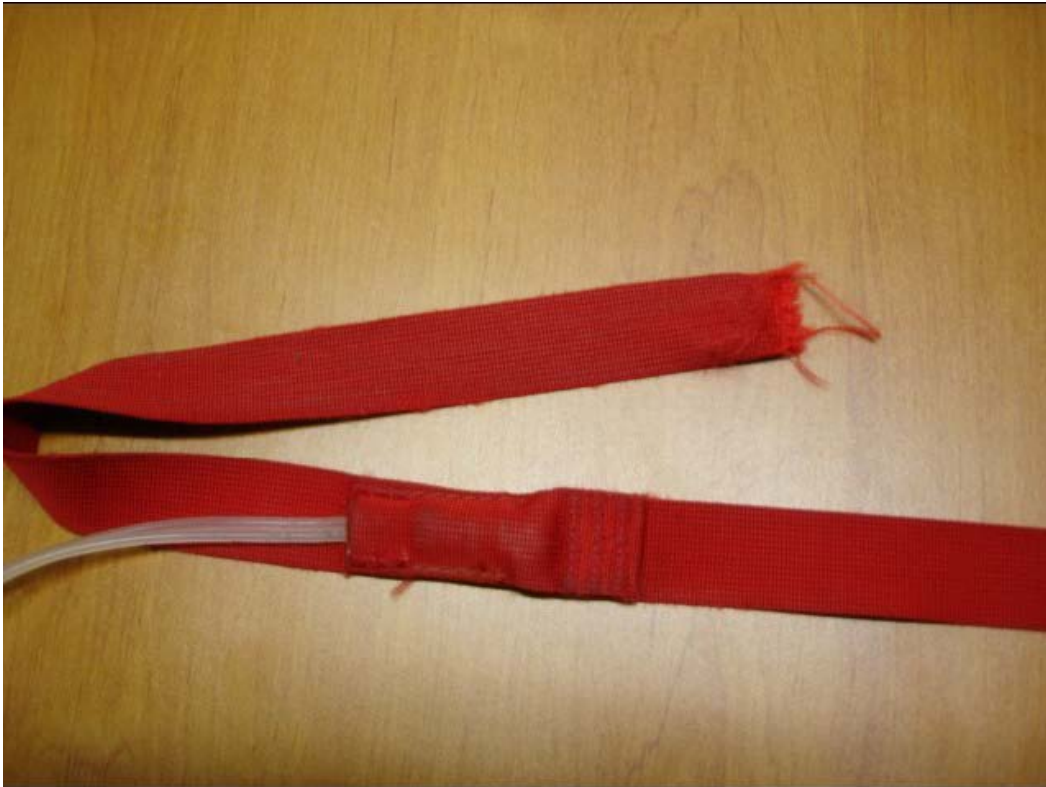
The analysis of the various incidents reveals several causes:

- 1) The bridle failed at the larks-head knot on the outlet side of the main deployment bag by wear and abrasion of the bridle against the ground and/or between the bridle and the right side flap of the deployment bag
- 2) The total failure of the bridle can occur following a fast deployment at the time of the drogue release.
- 3) The failure can happen where the two flexible pins are attached to the drogue by embrittlement of the drogue bridle caused by the repeated folding at the same place during packing.
- 4) In at **least one case, no explanation was found** for the bridle failure.

Following these reports, the manufacturer, Aerazur, **developed and tested a new product** with twice the tensile strength of these earlier bridles (900 kg instead of 450 kg).

Actions: to check the state of wear of your drogue bridle:

- If you note any wear or the start, however small, of a tear or stitching failure
 - on the larks-head knot on the outlet side of the main deployment bag,
 - or anywhere along the length of the bridle,
- the bridle **must** be immediately replaced before the next jump.

- If the bridle does not present any signs of wear or weakness, it must still be replaced -
 - if it has more than 200 jumps
 - at the latest by August 15, 2009

Meticulous examination must be repeated with each repack before this deadline.

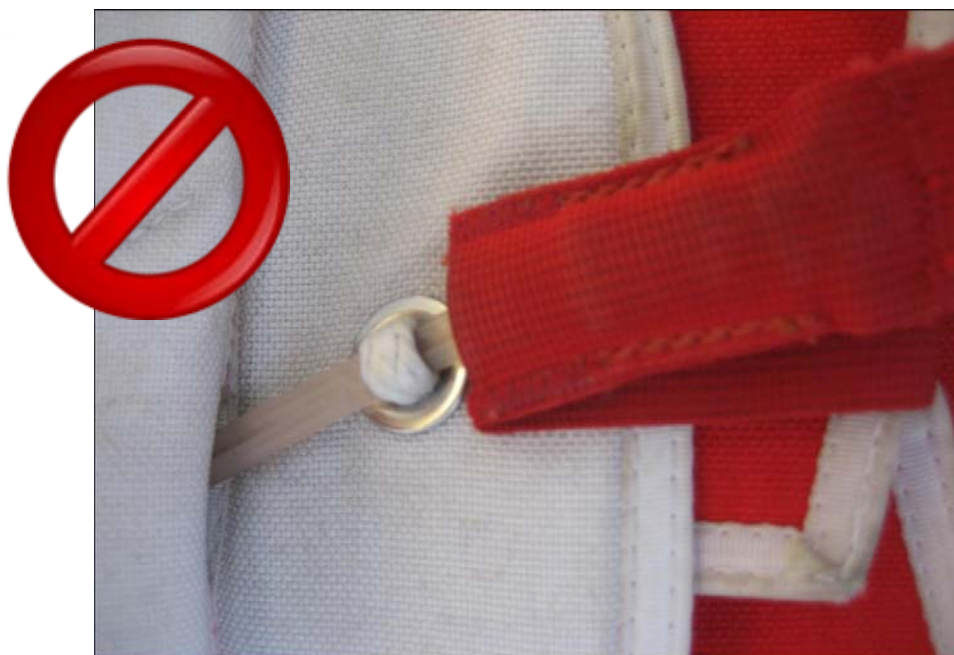
Please note: The engagement of the flexible pins into the tunnel-guide with the pins butted hard against the closing loop can cause an excessive loading and **IS an error of packing on the equipment Atom tandem**
